AECOM
558 North Main Street
Oshkosh, Wisconsin 54901

January 8, 2013

**Subject: Phase I Environmental Site Assessment of the Industrial/Municipal Properties
Located at 92 and 100 E Maple Street, Sturgeon Bay, Door County, Wisconsin
AECOM Project No. 60282378**

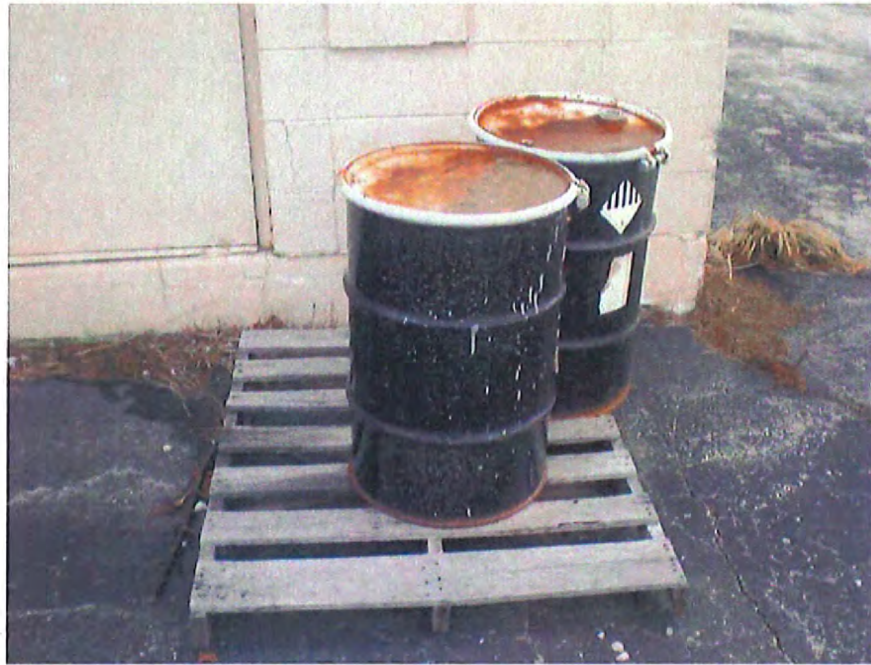
- Two unlabeled 55-gallon drums were observed on the west side of the Subject Property adjacent to the southwest corner of the former coop structure. The drums may be related to historic environmental work that may have occurred at the Subject Property and may contain soil or groundwater. The drums were stored on a wood pallet. Evidence to suggest a release from the drums was not observed at the time of the site reconnaissance.

Drums situated on a wood pallet adjacent to the former coop structure.

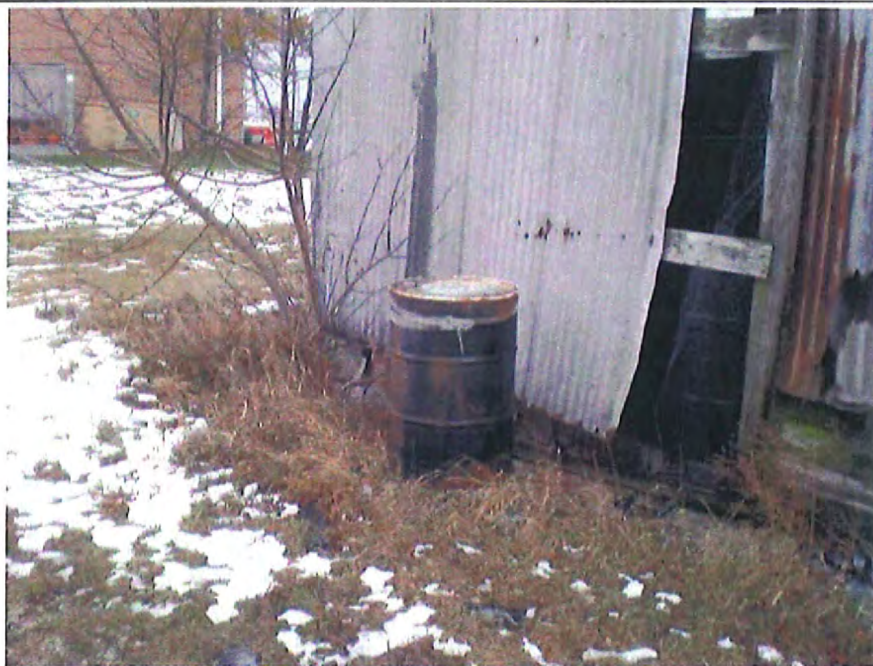
- A single 55-gallon drum was observed on the west side of the eastern warehouse structure on the Subject Property. The drum was not labeled and appeared to be in fair condition. Evidence to suggest a release of materials from the drum was not observed at the time of the site reconnaissance. However, stressed vegetation was observed between the drum and the west wall of the structure. This may be related to the staining observed at this location within the structure. This represents an REC to the Subject Property.

55-gallon steel drum located adjacent to the west side of the east warehouse structure.

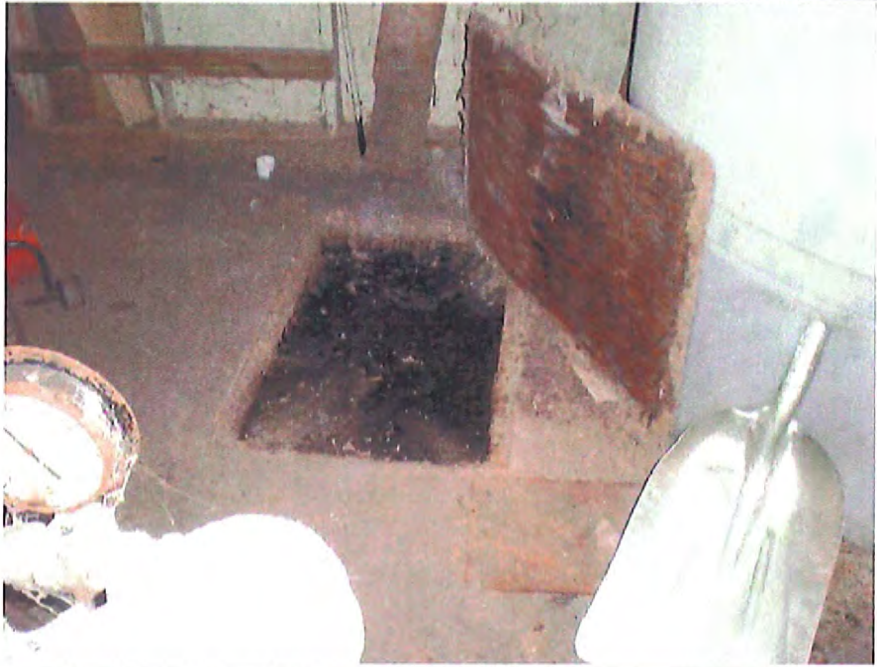
Client Name: City of Sturgeon Bay		Site Location: Former Door County Cooperative Property	Project No.: 60282378
Photo No. 21	Date: 12/14/12

- A shallow pit or depression located on the inside of the former coop structure was observed adjacent to a liquid feed above ground storage tank. The pit appears to be approximately 6 inches deep and is approximately four feet by three feet. A foul odor was encountered when the cover was removed from the pit. A thick black liquid was observed in the pit. The material observed within the pit is unknown. It may be related to the adjacent liquid feed tank; however, this has not been confirmed. This poses an REC to the Subject Property.

Direction Photo Taken: West			
Description: Pit with black material located in the former coop structure.

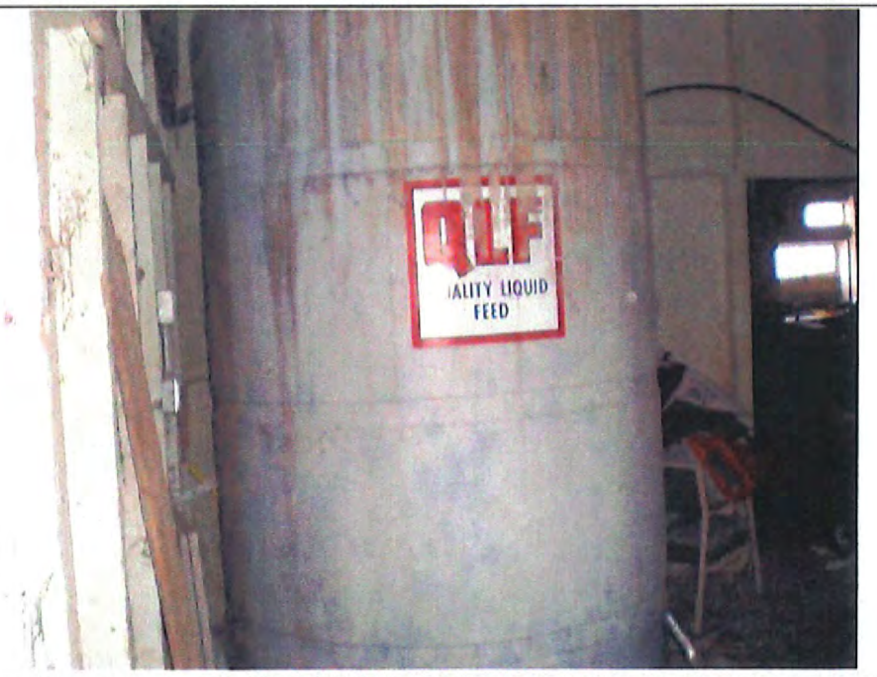
Liquid feed AST located in the former coop structure.

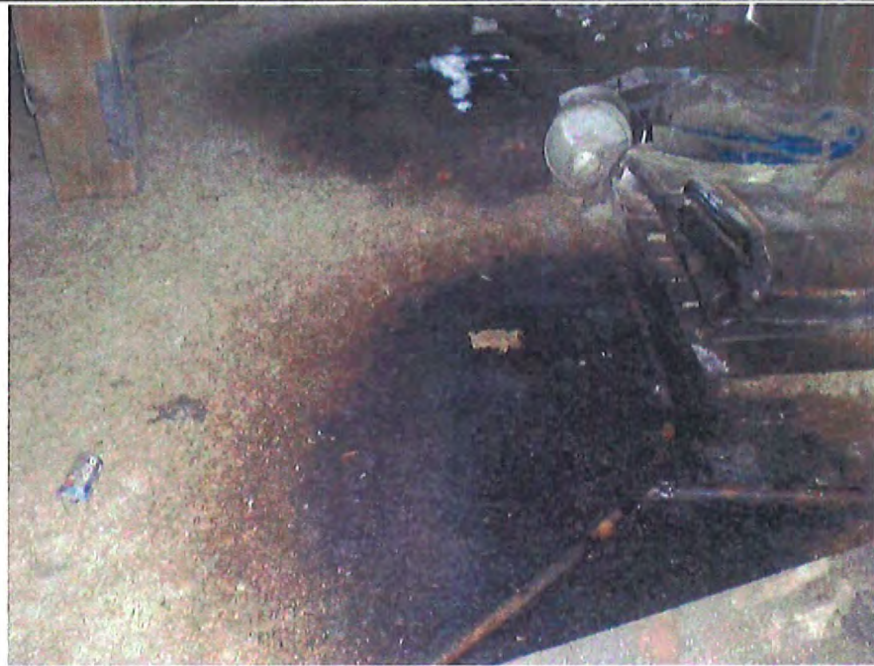
- A significant amount of staining that appears to be petroleum in nature was observed within the elevator portion of the former coop structure. The flooring within this portion of the structure is constructed of wood planking with gaps allowing a route for materials to move from the interior of the structure to the exposed ground surface located beneath the flooring of the structure. This poses an REC to the Subject Property.

Staining observed on the floor of the elevator structure portion of the former coop structure.

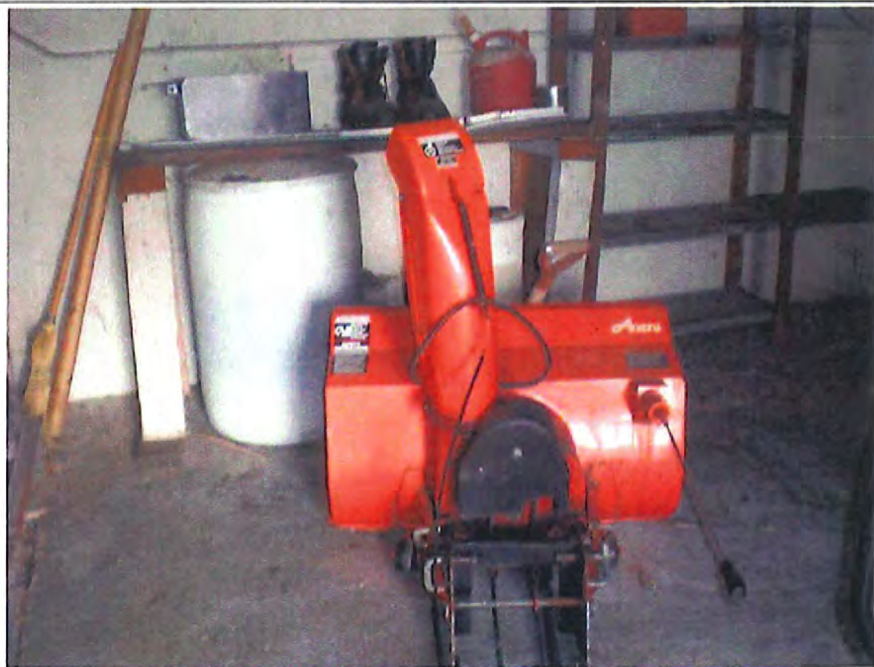
- Various drums, paint cans, and containers with unknown materials were observed throughout the former coop property. This material needs to be secured and handled in accordance with State and Federal regulations. This represents an REC to the Subject Property.

Drums with unknown material, oil, and gasoline containers located on the west side of the southern warehouse structure.

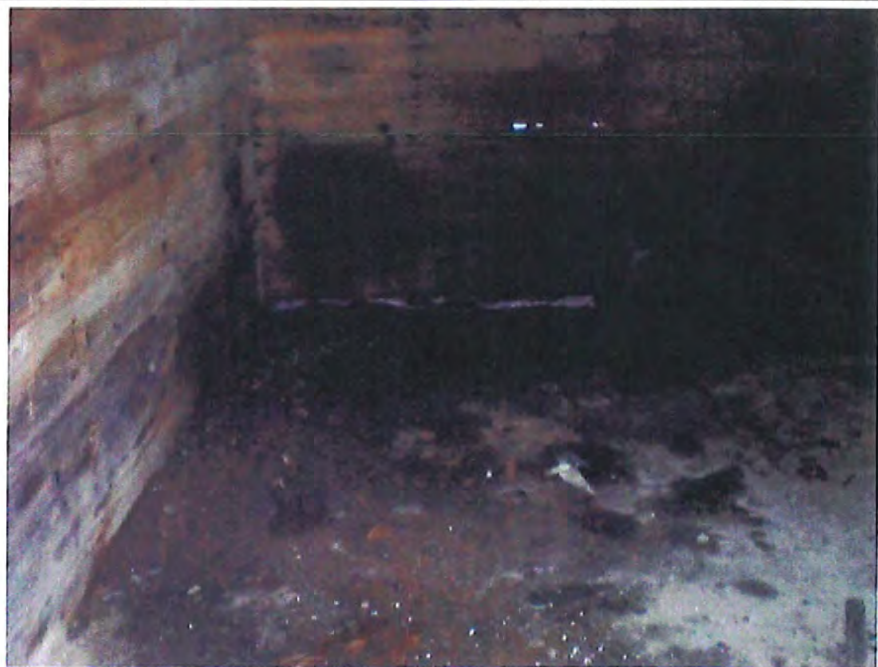
- The warehouse structure located on the east side of the Subject Property has historically been utilized for storage of agricultural products, fertilizers (including fertilizer mixing), and more recently storage of petroleum products and lubricants. Unlabeled drums and smaller containers were observed within the structure. In addition, multiple areas of apparent oil or petroleum product related staining was observed within this structure. The flooring within the structure consists of concrete. Floor drains were not observed while conducting the site reconnaissance. However, the concrete flooring was observed to be in fair to poor condition and damaged in places. Stained surfaces were also observed adjacent to exterior walls. Information related to subsurface assessment activities conducted in 2005 did not reveal evidence to suggest a release of petroleum products or hazardous materials within the structure. However, based on the current observations, conditions within the structure have changed since 2005 and the potential exists for the materials that caused the staining within the structure to have either impacted the subsurface of the Subject Property beneath the concrete flooring and/or have impacted soils on the exterior of the structure where the walls of the structure connect to the concrete flooring of the structure. This poses an REC to the Subject Property.

Oil stained flooring along the north exterior wall of the east warehouse structure.

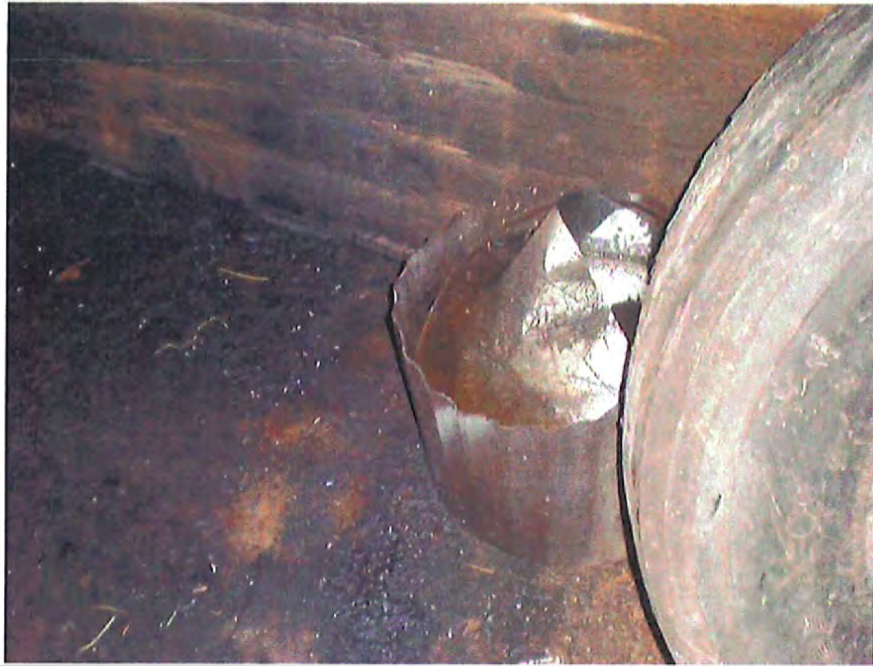
Oil stained flooring and waste oil pale located in the east warehouse structure.

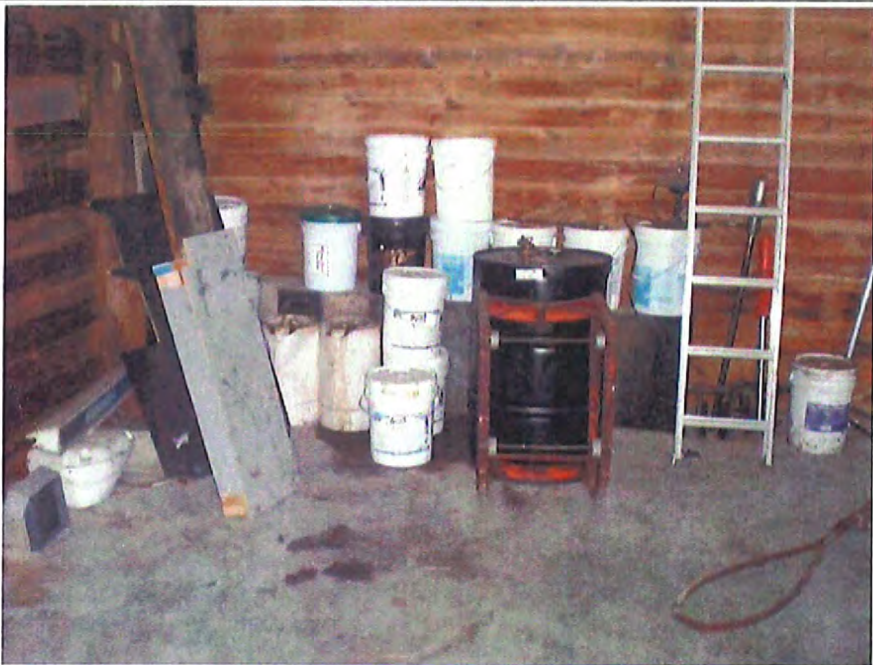
Oils and lubricants stored inside the east warehouse structure.

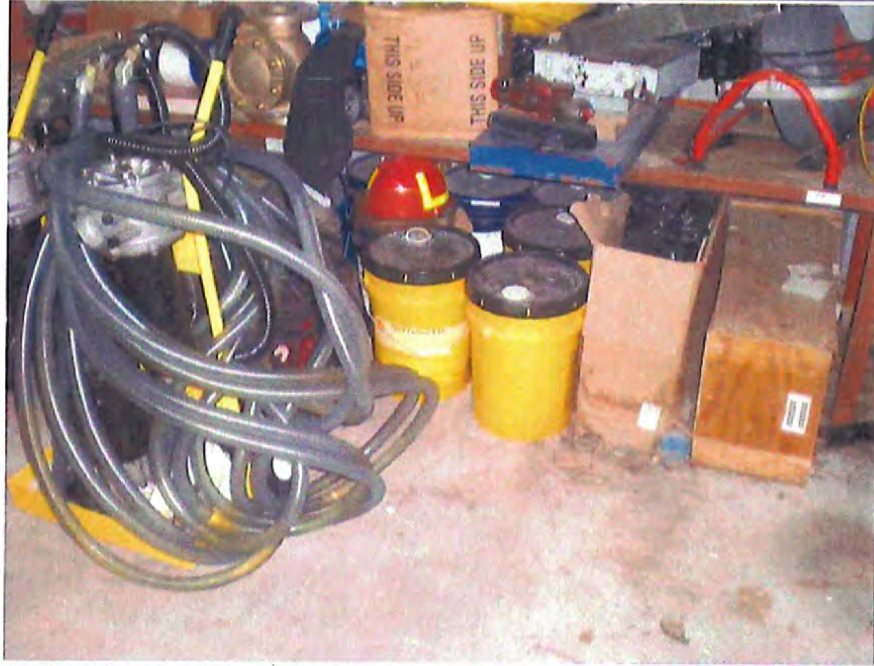
Bulk oil containers located within the United States Coast Guard storage structure.

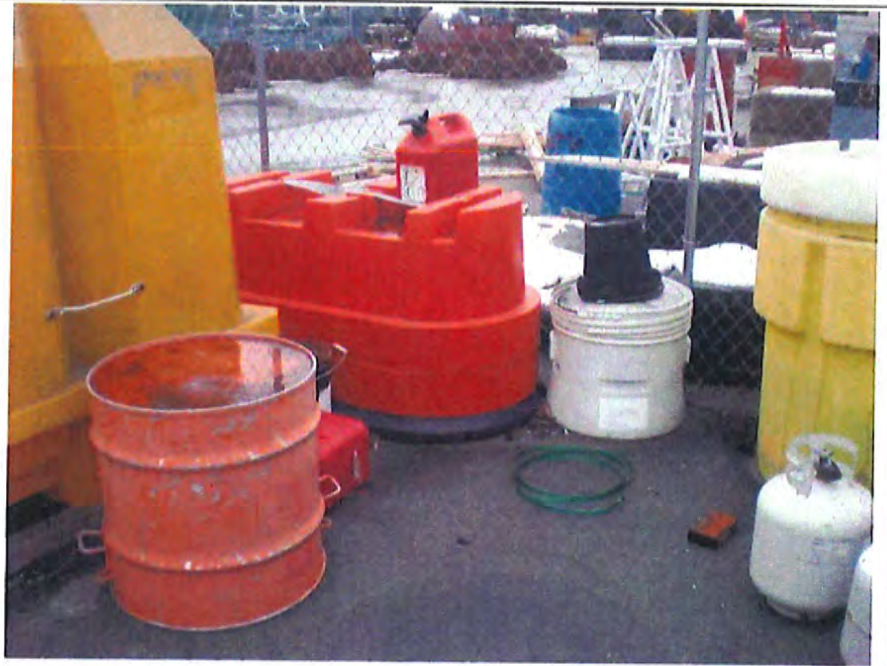
Petroleum storage area located within the fenced area on the south side of the subject property.
