AFFIDAVIT OF LORI HUNTOON, PG

RE: Technical Review, Friends of the Sturgeon Bay Public Waterfront

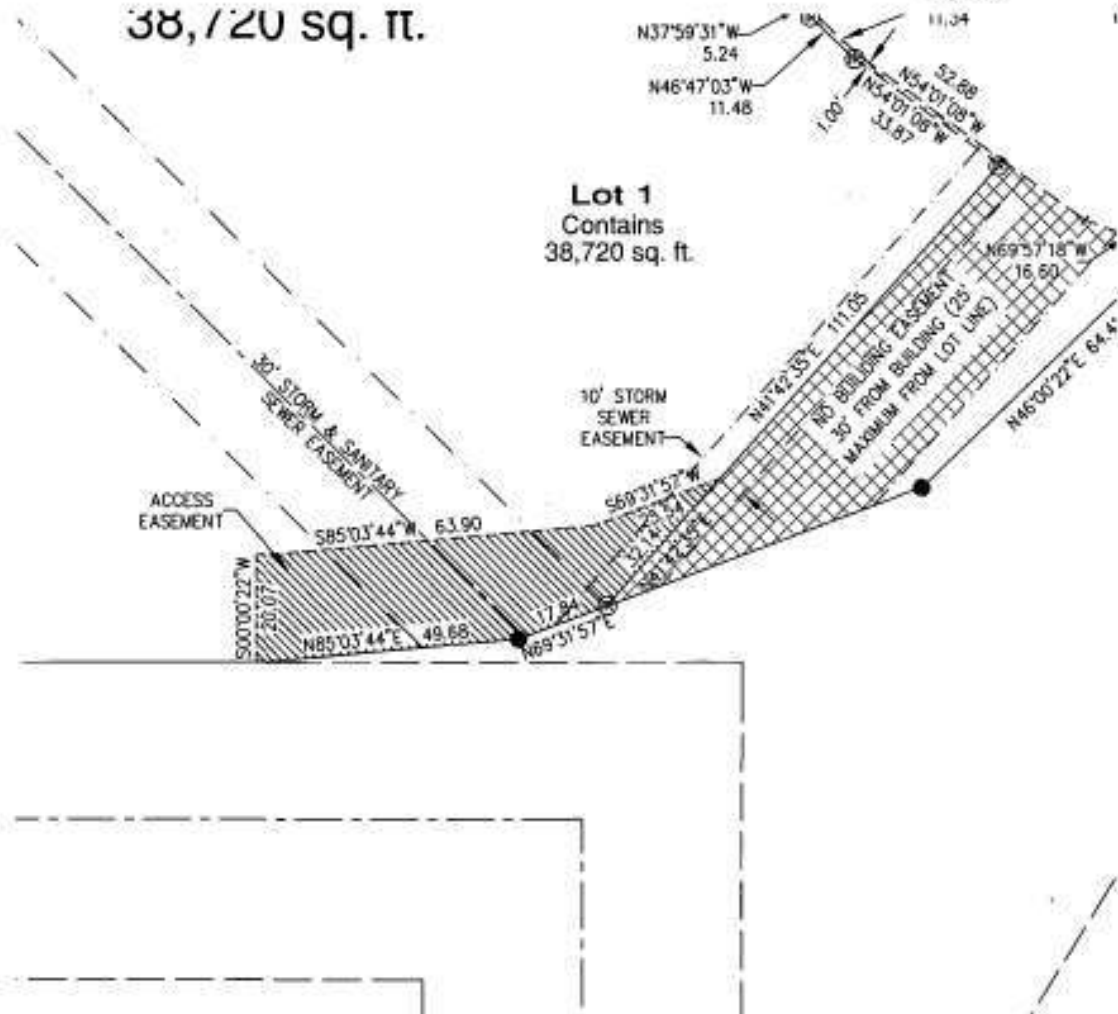
CERTIFIED SURVEY MAP

BEING:
PART OF LOT 1, BLOCK 9 OF HARRIS FIRST ADDITION AND
ALSO A PART OF LOTS 1, 6 AND 7, BLOCK 8 OF BAYVIEW
PLAT AND ALL OF LOTS 2, 3, 4 AND 5, BLOCK 8 OF BAYVIEW
PLAT AND ALSO PART OF SUBDIVISION 76
AND BEING LOCATED IN:
THE NE 1/4 OF SECTION 7, T. 27 N., R. 26 E.,
CITY OF STURGEON BAY, DOOR COUNTY,
WISCONSIN.

A technical review has been completed for the Friends of the Sturgeon Bay Public Waterfront (FSBPW) in order to render an opinion as to the nature of the subsurface of the properties located at 92 East Maple Street (Door County Parcel Number 2811210080101) and 100 East Maple Street (Door County Parcel Number 2812415090101), Sturgeon Bay, Wisconsin (hereinafter referred to as the "Redevelopment Property"). Review included the fill areas within the "Hotel Site", defined as the area identified on the Certified Survey Map included as Attachment 1, as follows:

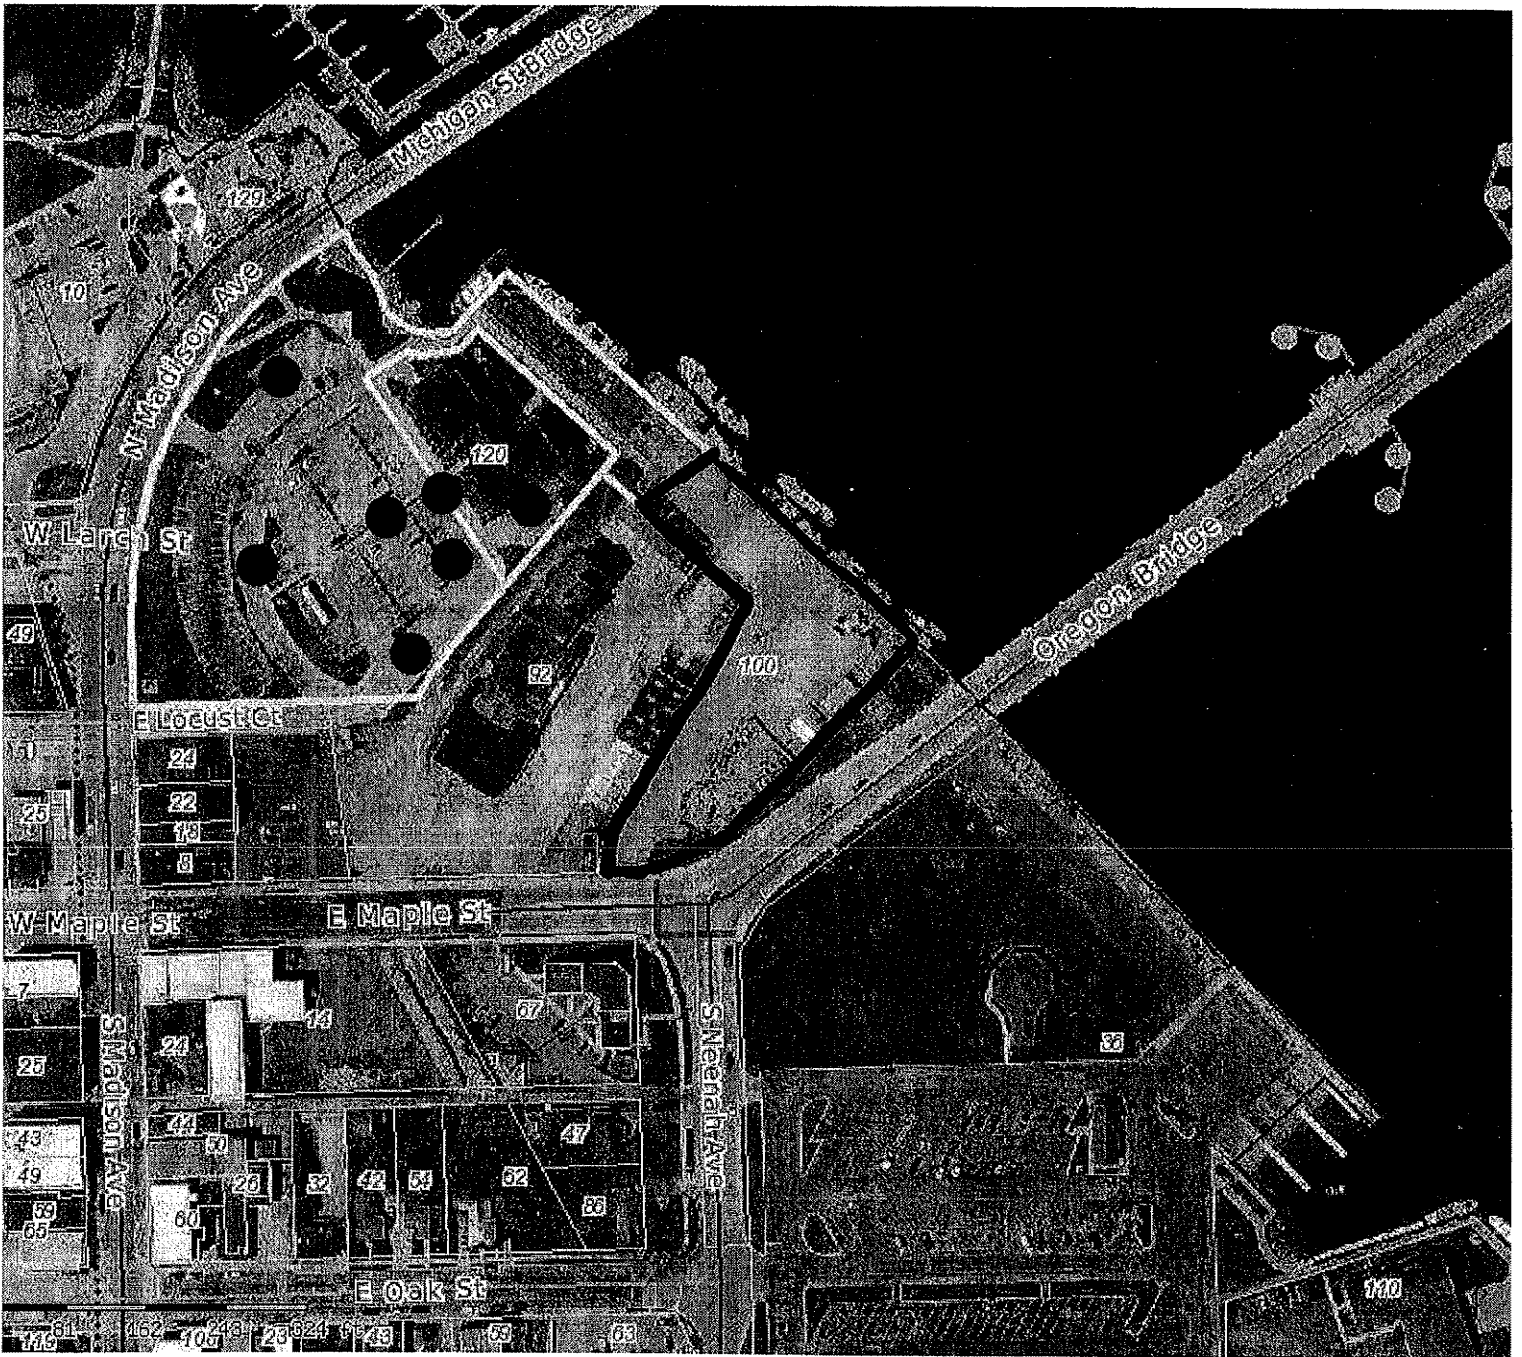
Illustration prepared as Attachment 2, Technical Review, FSBPW, Huntoon Environmental Consulting, LLC.

Wisconsin Department of Natural Resources (WDNR) Bureau of Remediation and Redevelopment Tracking System (BRRTS on the Web) provides the GIS Registry Package which includes geologic cross-sections of 8 borings installed on the proposed Maritime Museum site during investigation activities in 1995, results which **indicate fill across the Maritime Museum site adjacent to the Hotel Site, including debris and wood observed at depths exceeding twelve feet below land surface.** A map illustrating the locations of these borings with respect to the location of the Hotel Site is provided as Attachment 2.

● Symbol indicates soil borings installed during Environmental Site Assessment for Proposed Maritime Museum, City of Sturgeon Bay, WI. Based on Figure 2A - Site Detail Map, OMNNI Associates, prepared 07/95. Included in Final Site Closure for Maritime Museum, WDNR GIS Registry Package, WDNR # 02-15-000579.

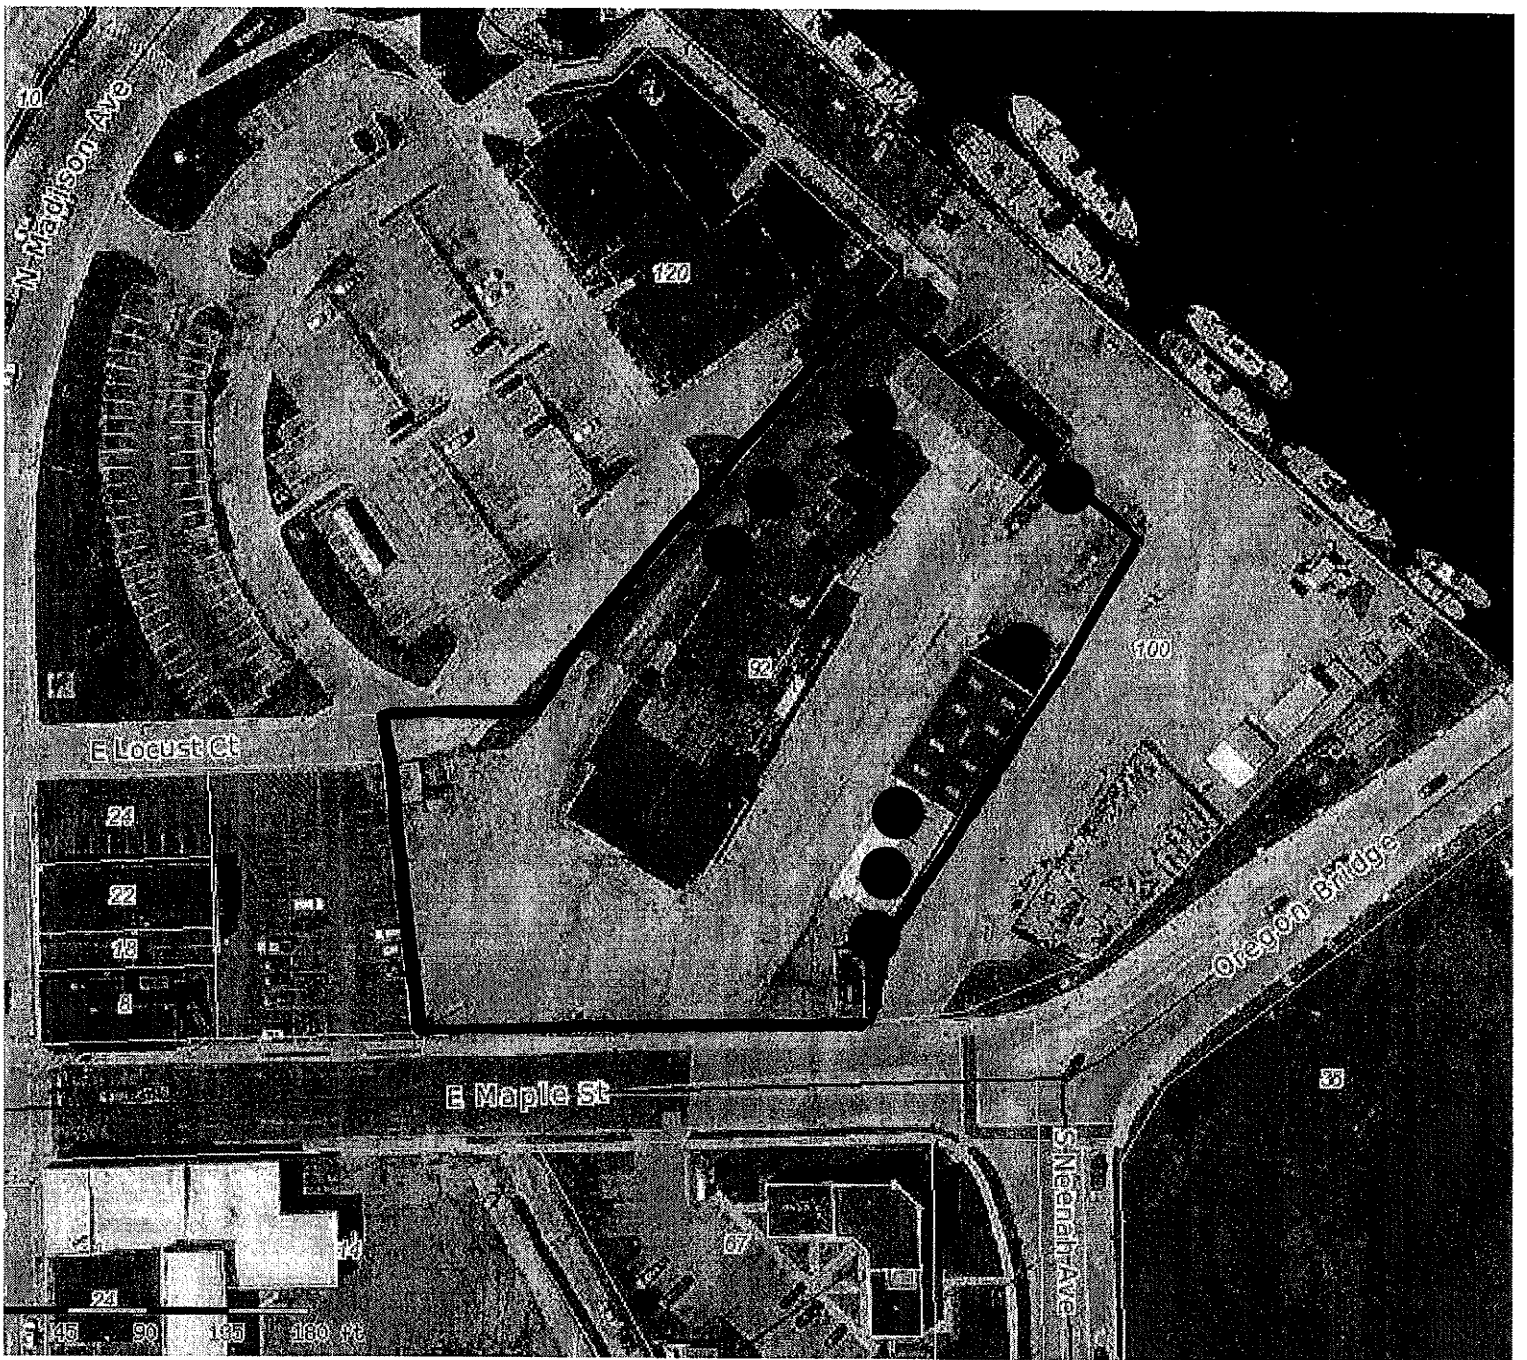
Illustration prepared as Attachment 3, Technical Review, FSBPW, Huntoon Environmental Consulting, LLC.

STS Consultants, Ltd., Prepared for Door County Cooperative, 92 East Maple Street, Sturgeon Bay, WI. October 12, 2005. The installation of 8 soil borings confirmed the presence of fill in the area of the Hotel Site. A map illustrating the locations of these borings on the Hotel Site is provided as Attachment 3.

● Symbol indicates soil borings installed during Phase II Environmental Site Assessment for Door County Cooperative, 92 East Maple Street, Sturgeon Bay, WI. Based on Figure 2, STS Consultants, Phase II Subsurface Assessment and Asbestos Demolition Survey, 10/12/05.

*Subsurface conditions encountered during the Phase II **were generally described as fill** consisting of brown fine to coarse silty sands and fine to coarse sands with gravel to the boring termination depths. **Trace cinders were observed at a depth of approximately 0.5 to 2 feet bgs at Borings B-3 and B-8. Trace wood was observed at a depth of approximately 6 to 8 feet bgs at Boring B-4, and trace wood and glass were observed at a depth of approximately 2 to 8 feet bgs at Boring B-8.***

- B-3 - cinders observed in soil sample collected from 0-2 feet below land surface
- B-4 - trace wood and gravel observed in soil sample collected from 6-8 feet bls
- B-8 - trace cinders observed in soil sample collected from 0-2 feet bls
trace wood and trace glass in soil sample collected from 2-4 feet bls
trace cinders and trace wood in soil sample collected from 4-6 feet bls
trace wood in soil sample collected from 6-8 feet bls
