AECOM
558 North Main Street
Oshkosh, Wisconsin 54901

January 8, 2013

**Subject: Phase I Environmental Site Assessment of the Industrial/Municipal Properties
Located at 92 and 100 E Maple Street, Sturgeon Bay, Door County, Wisconsin
AECOM Project No. 60282378**

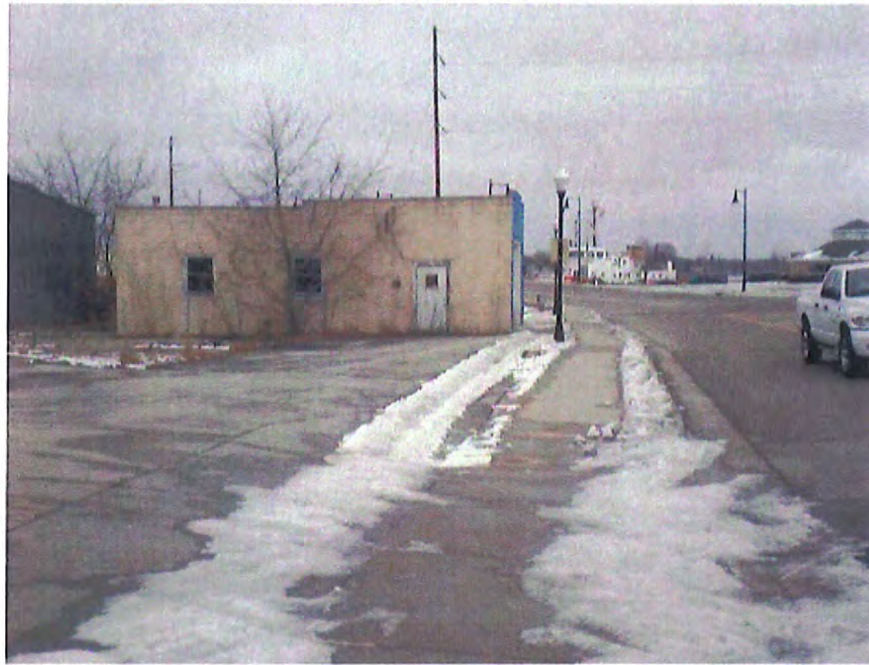
Structure located along the south side of the subject property along East Maple Street.

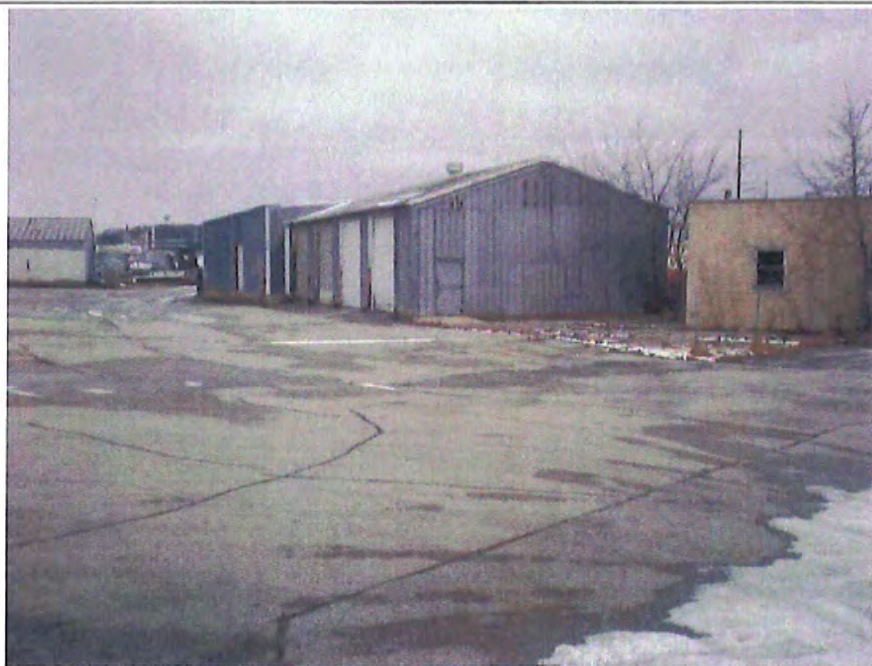
Photo No.
2

Small storage structure on the south side of the subject property and the south warehouse structure.

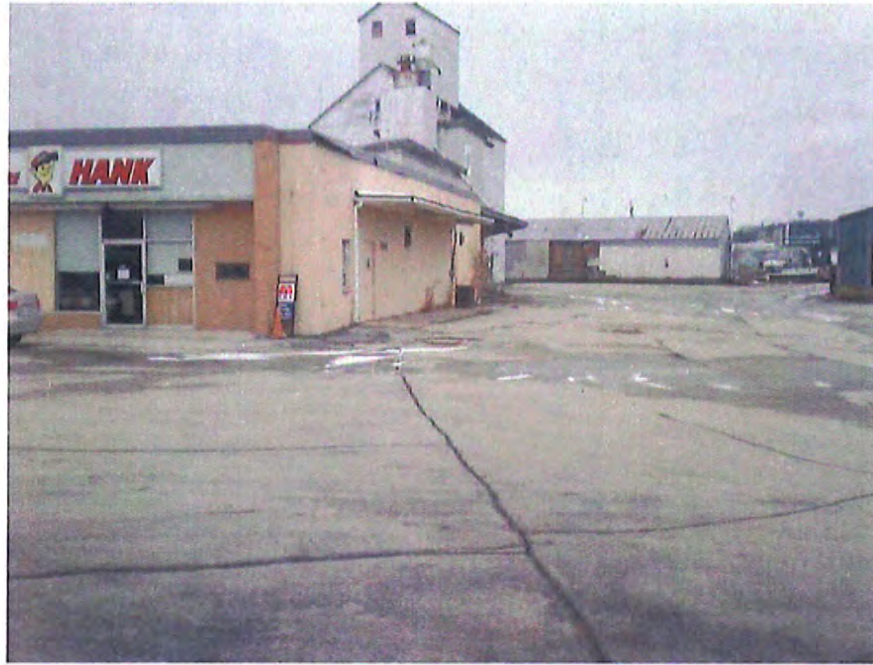
Former coop structure.

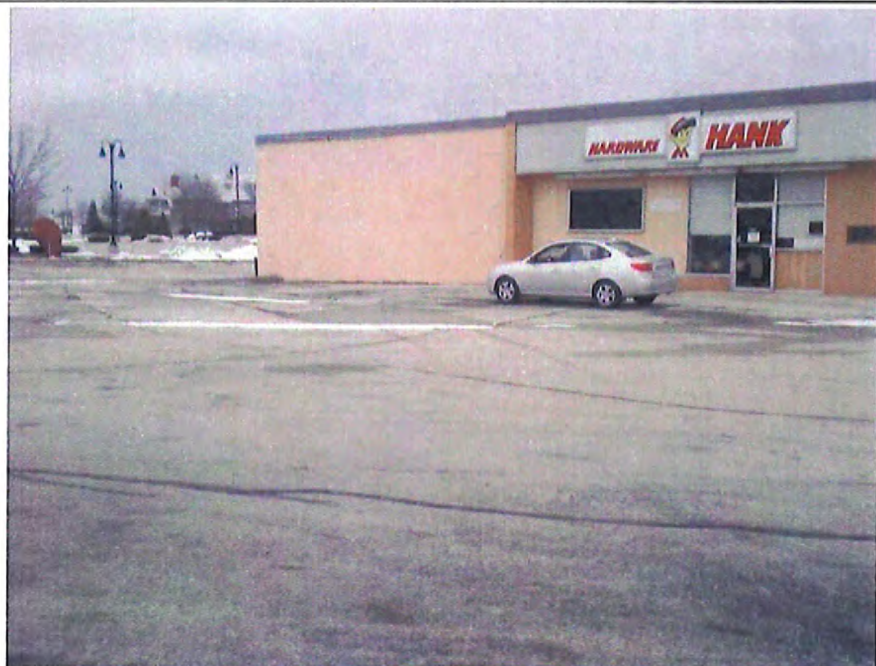
Photo No.
4

Former coop structure and north west side of the subject property.

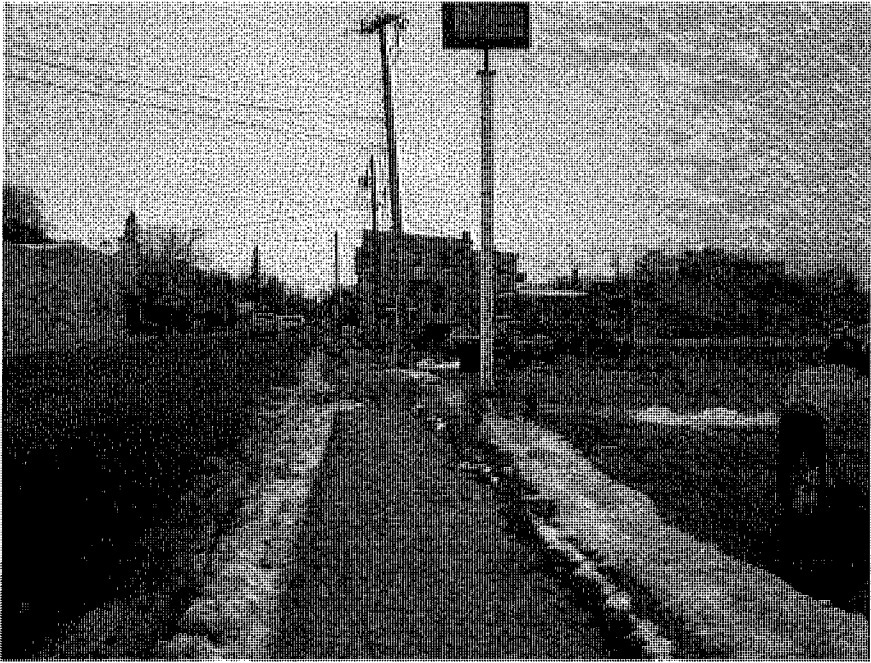
Direction Photo Taken: West			
Description: East Maple Street, south and west sides of the subject property, and commercial structures beyond.

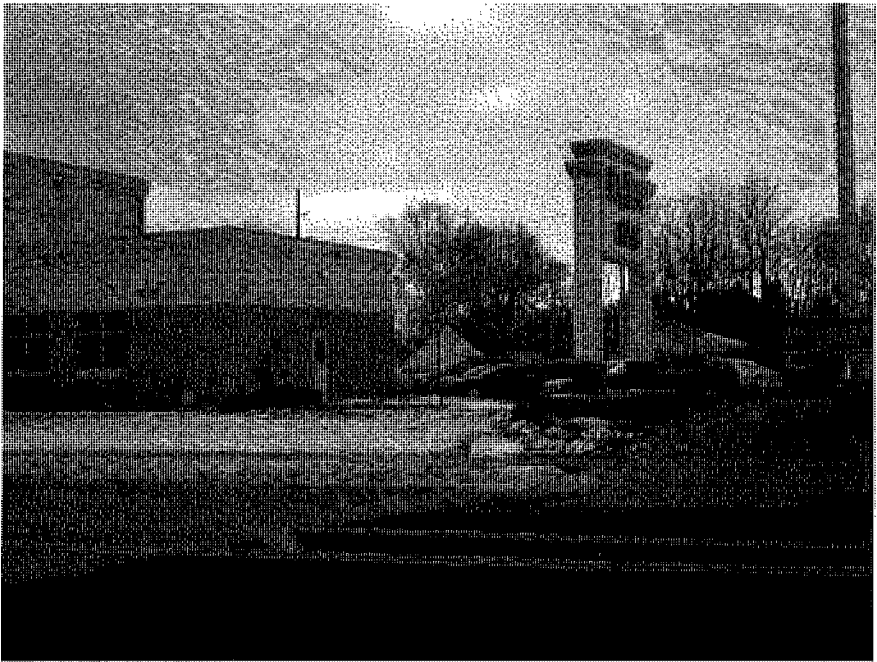
Photo No. 6	Date: 12/14/12

Direction Photo Taken: South			
Description: East Maple Street and commercial property beyond.

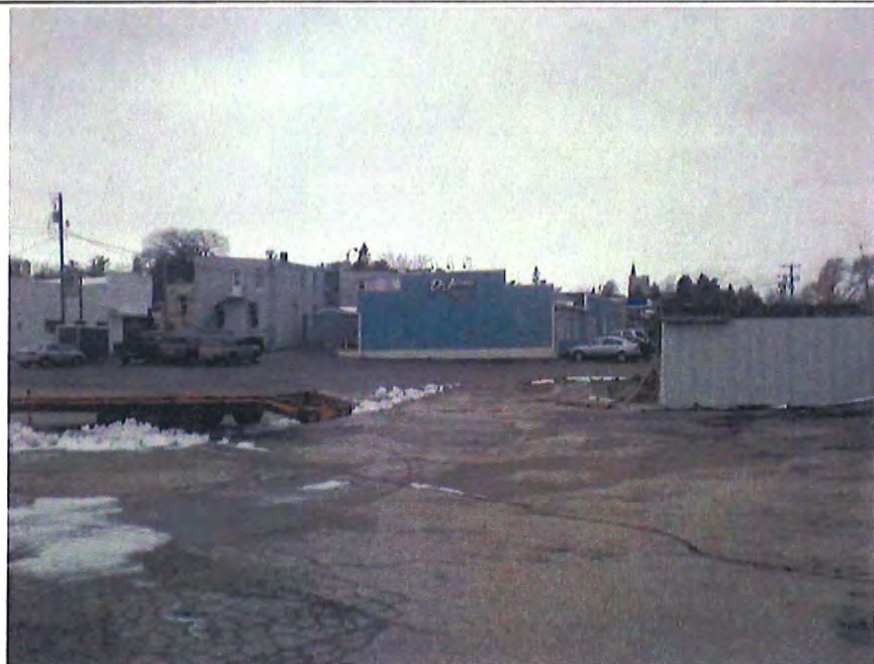
West side of the subject property.

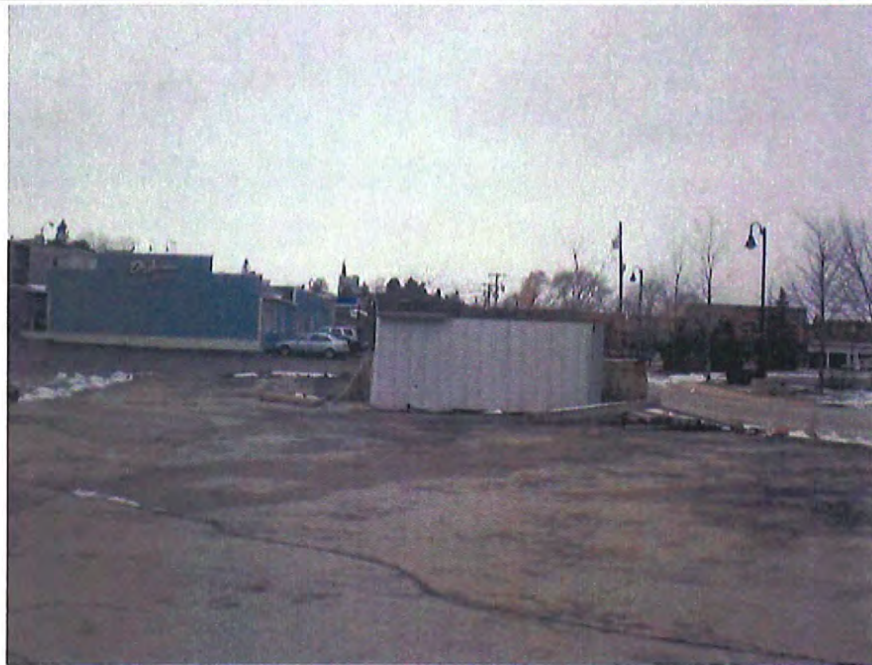
Former propane storage area.

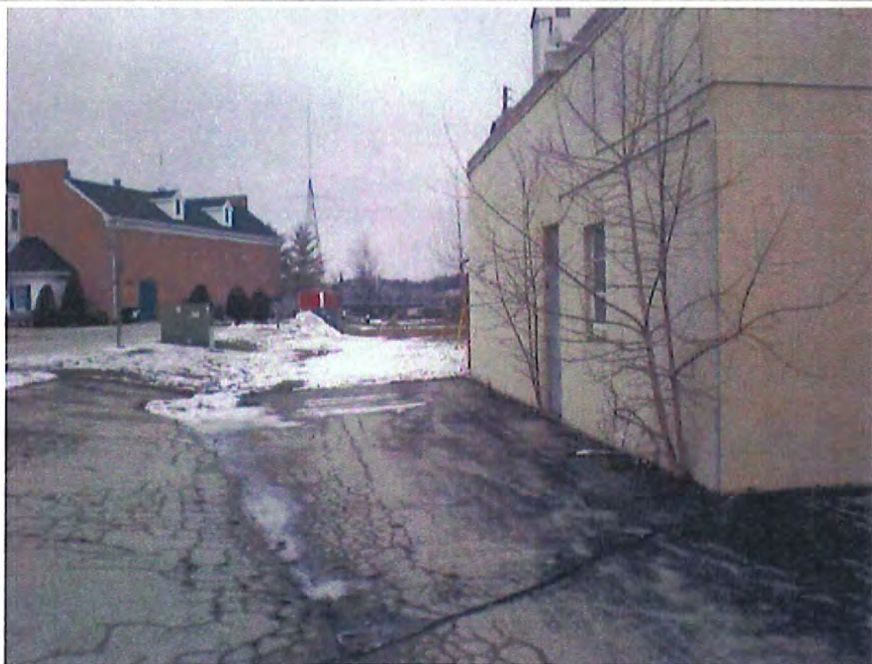
Photo No.
10

Looking at north side of the former coop structure.

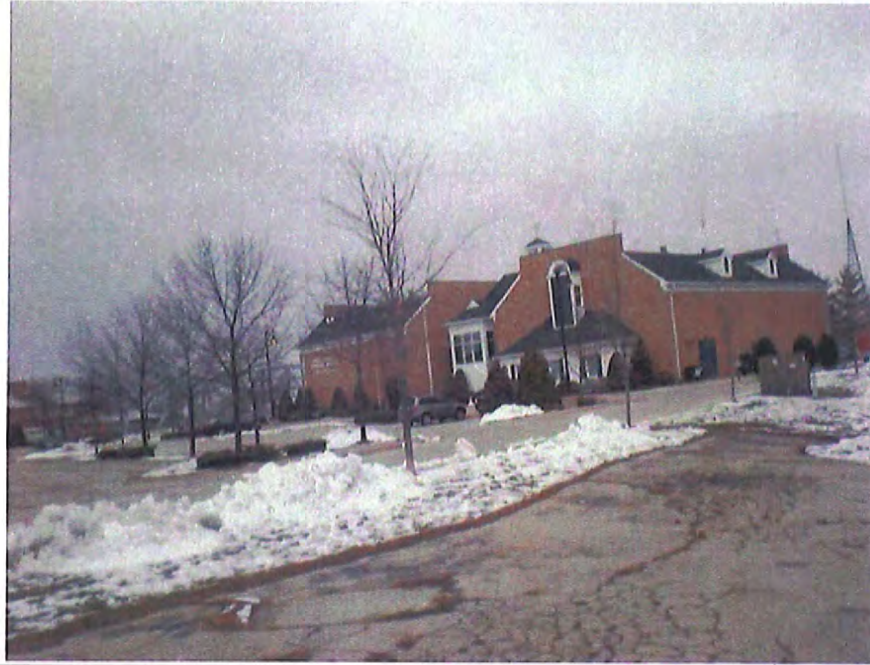
Door County Maritime Museum located adjacent and north of the subject property.

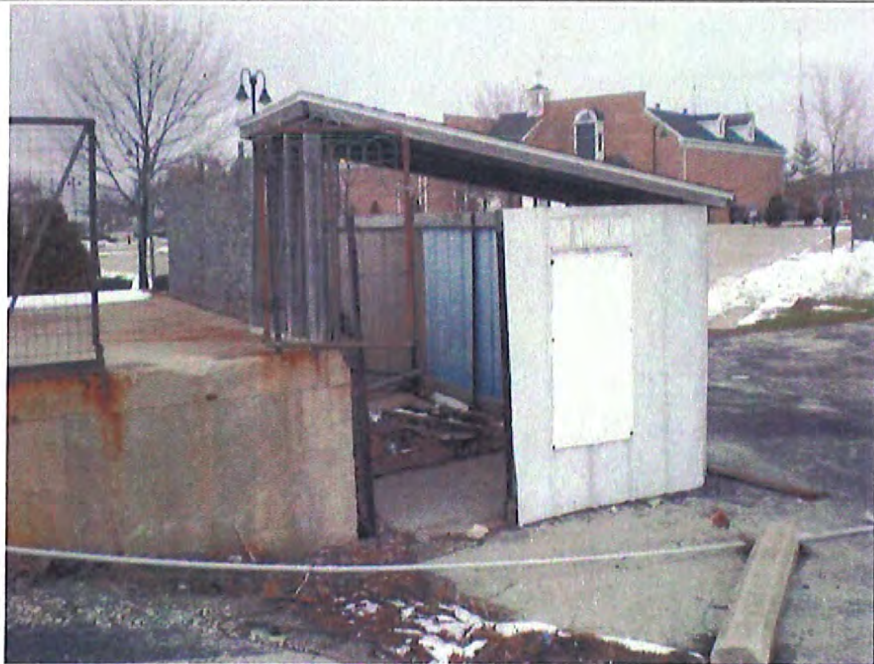
Photo No.
12

Former propane storage area.

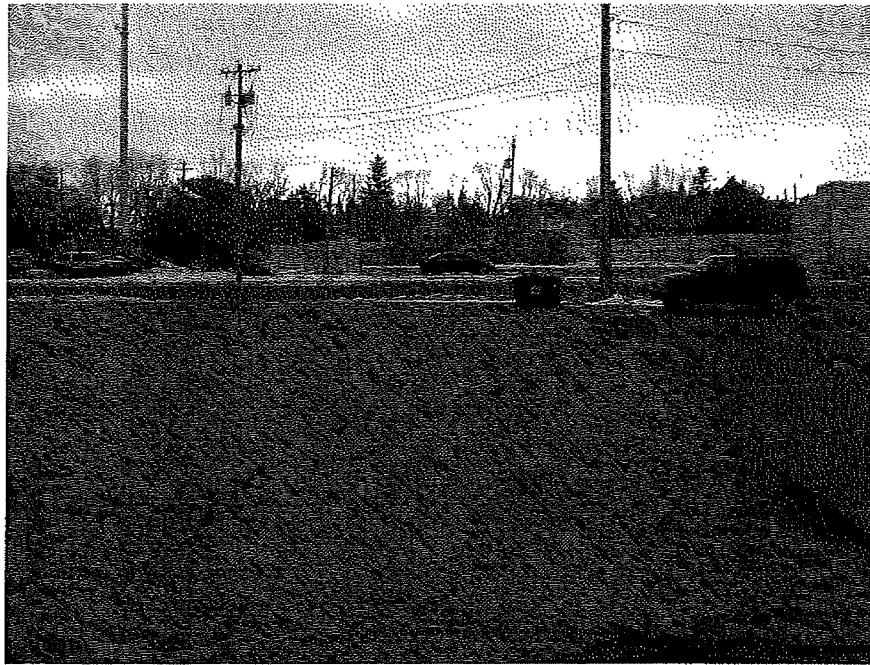
West side of the subject property.

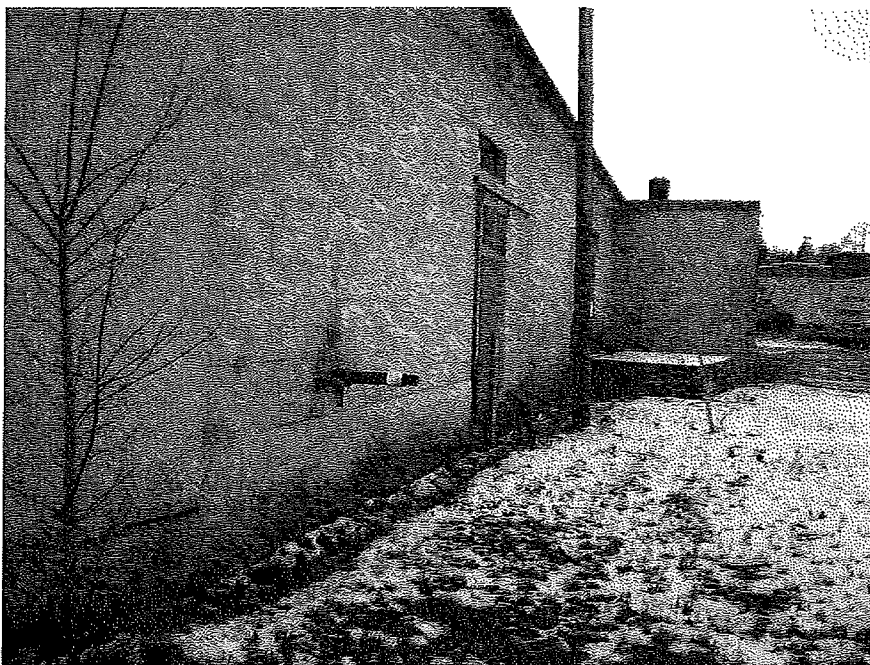
Photo No.
14

Looking at the north side of the former coop structure and piping for fire control.

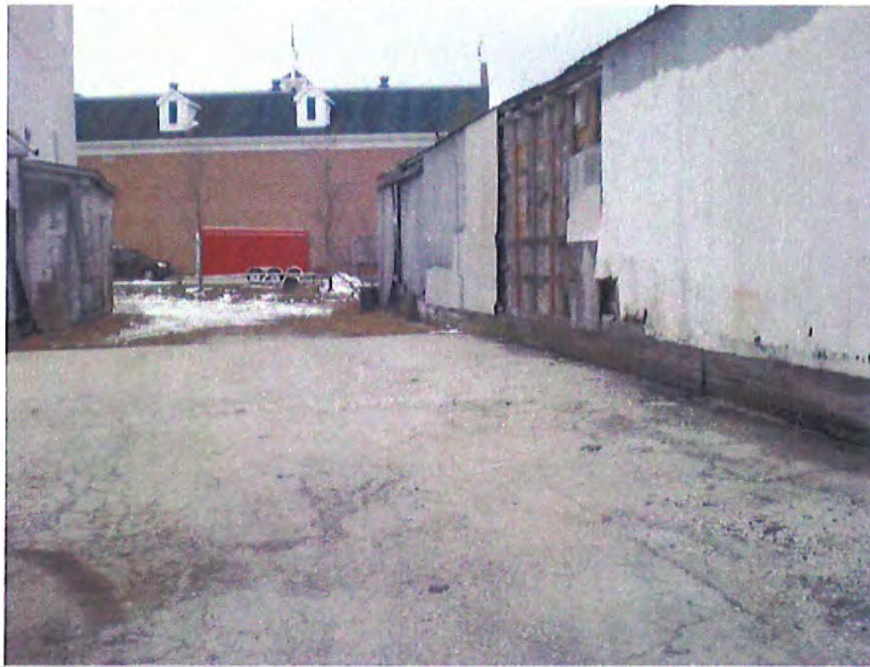
Looking at the west side of the east warehouse structure and the east side of the former coop structure.

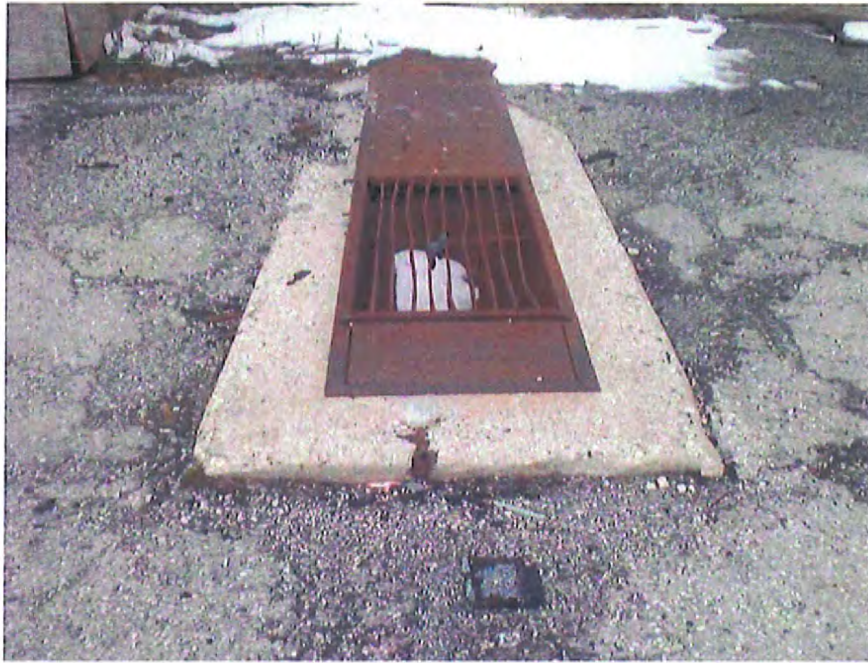
Grain conveyor located adjacent and south of the former coop structure.

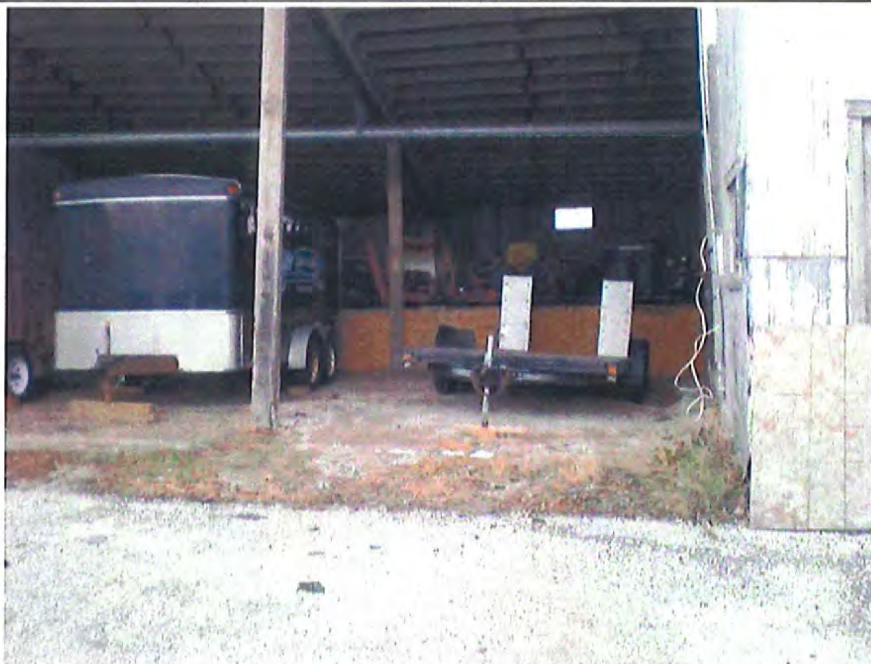
Photo No.
18

Trailer and lawn mower attachment storage in the former coop structure.

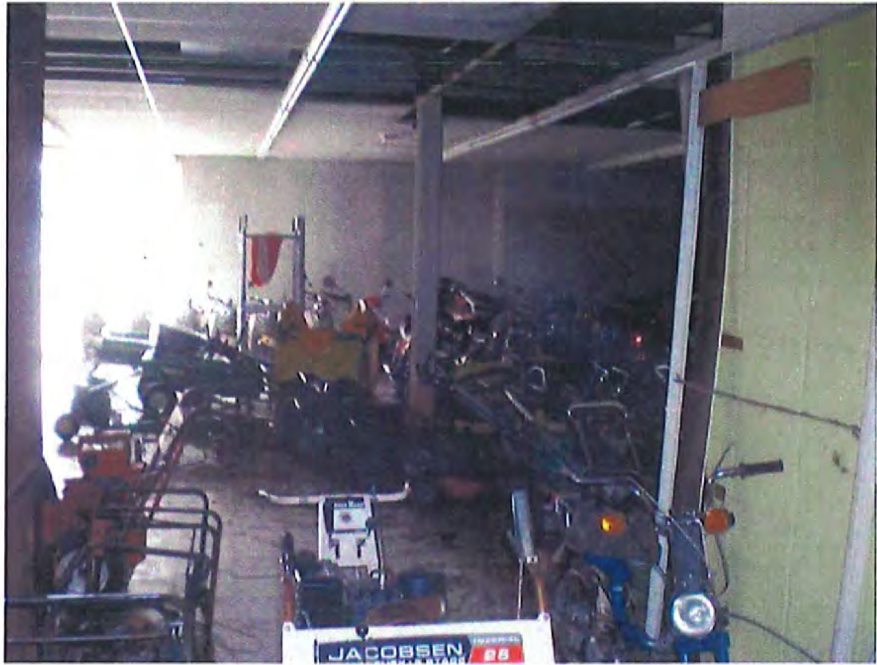
Stored small engine equipment, motorcycles, and scooters in the former coop structure.

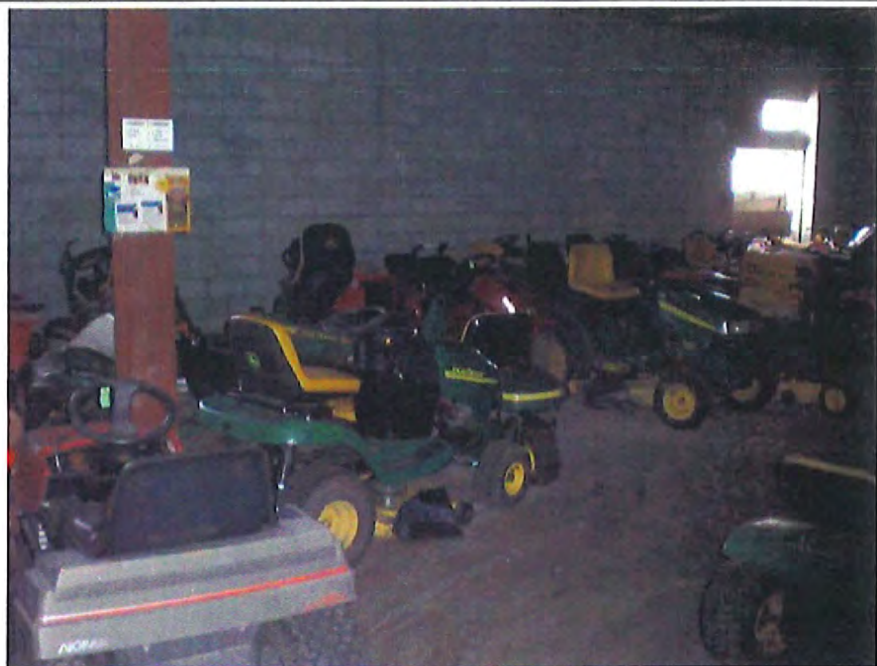
Lawn tractors stored in the former coop structure.

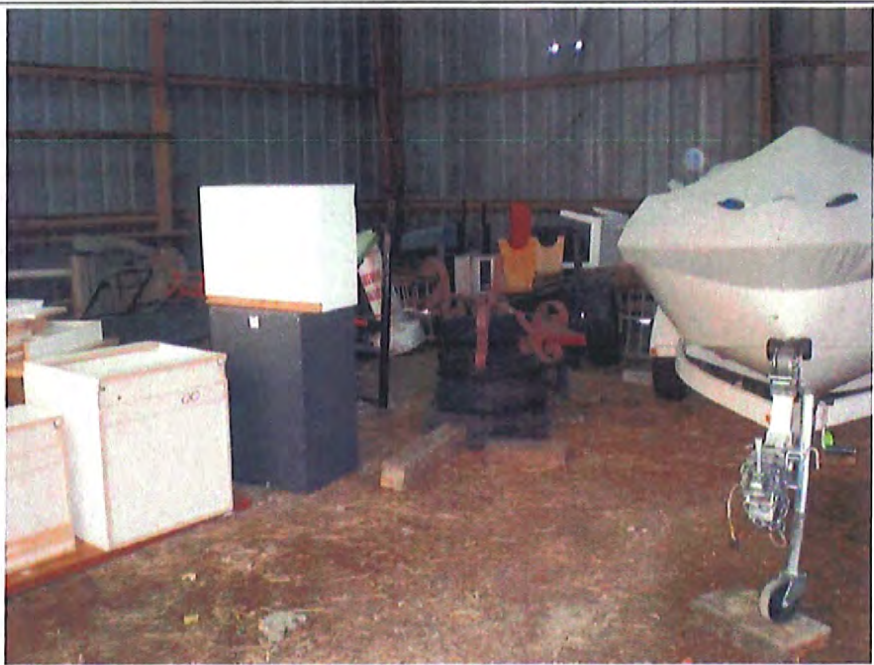
Stored items located in the southern warehouse structure.

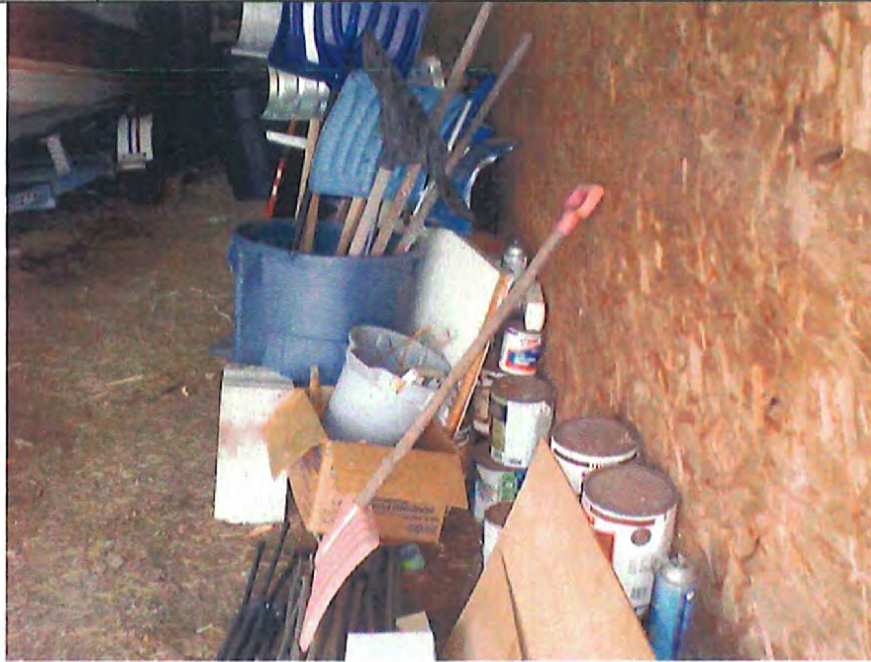
Paint stored on the earthen floor of the southern warehouse structure.

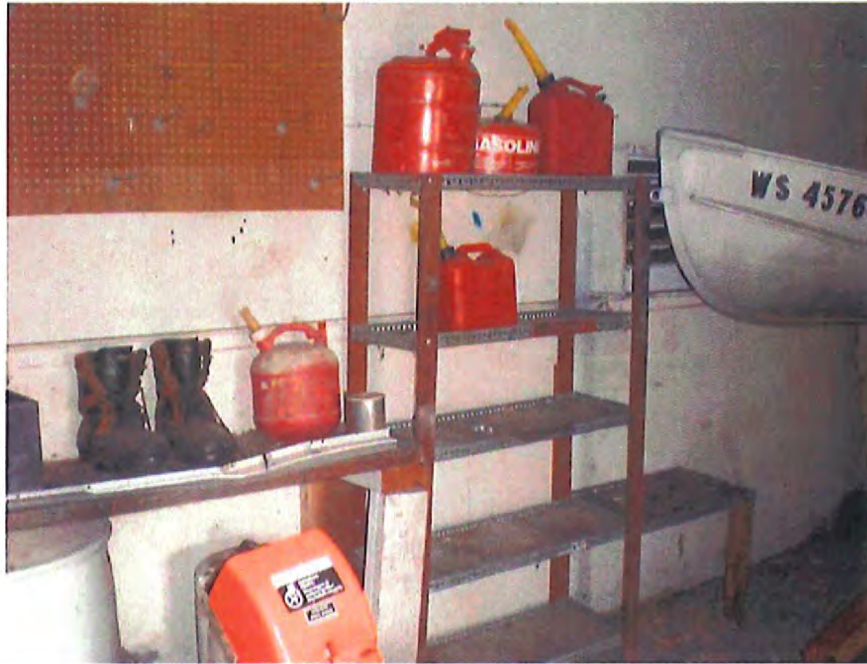
Gasoline containers located on the west side of the southern warehouse structure.

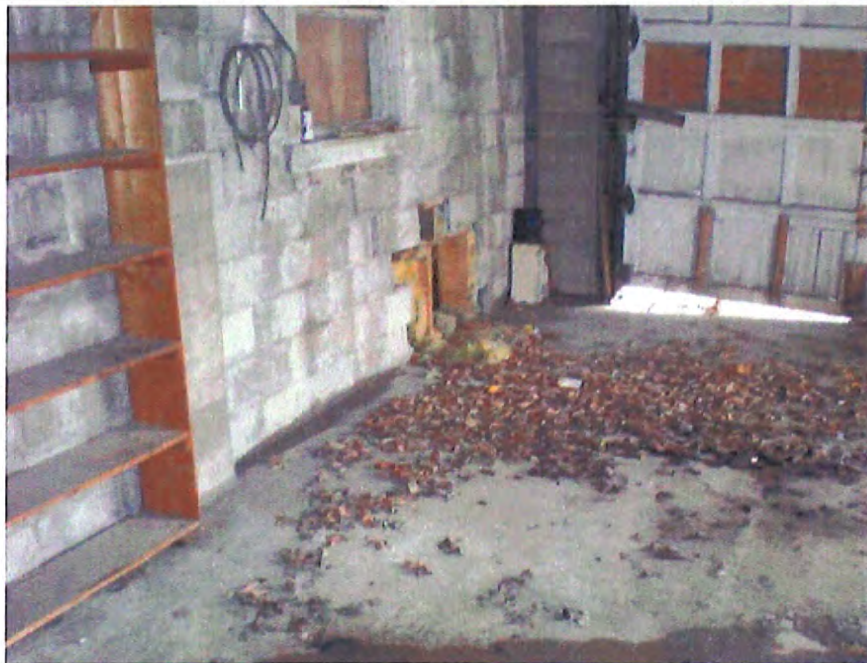
Photo No.
30

Paint can and interior view of the small structure located on the south side of the subject property.

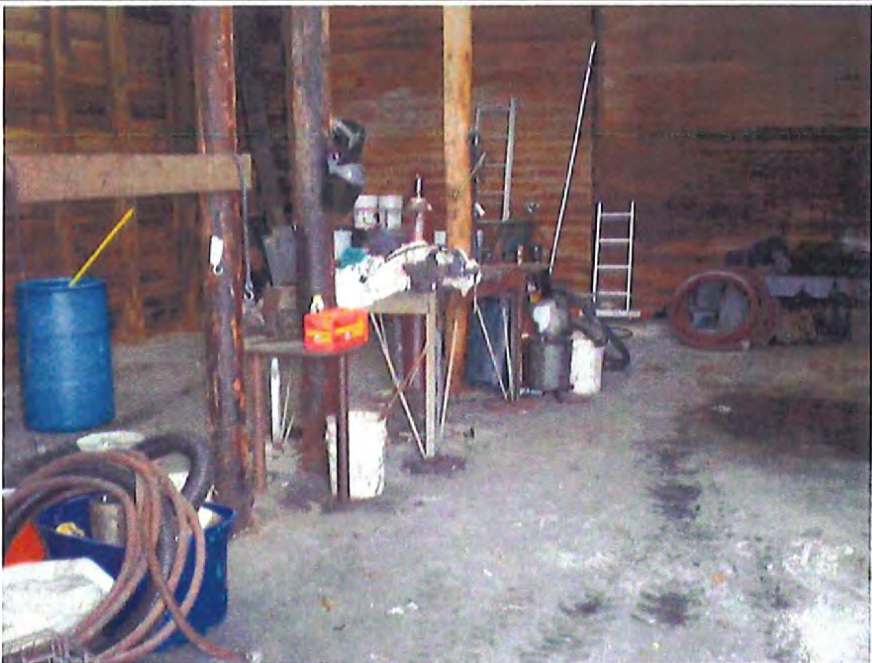
Photo No. 32	Date: 12/14/12

Direction Photo Taken: West			
Description: Interior of the east warehouse structure.

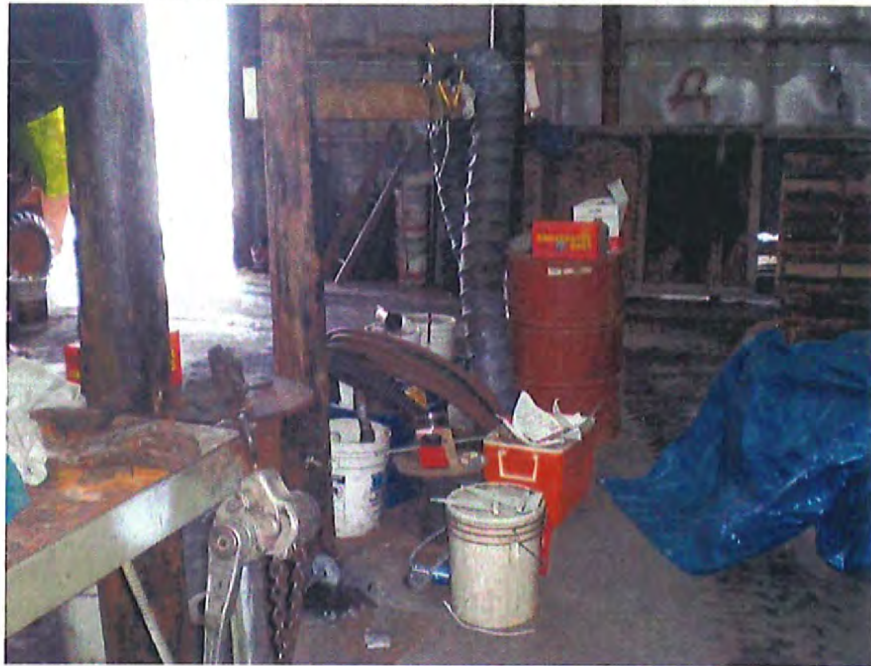
Stored items within the east warehouse structure.

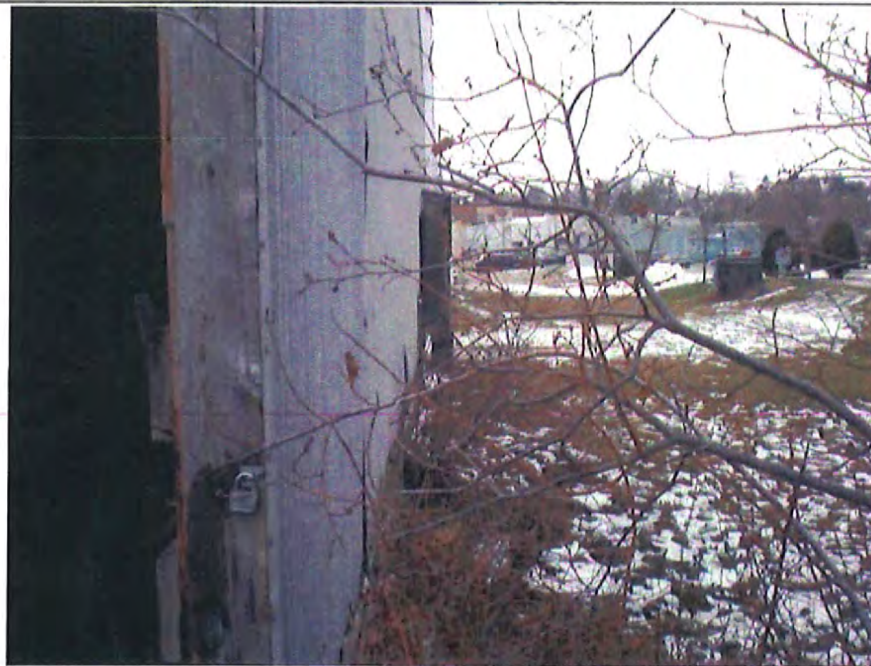
Photo No.
40

Looking at the north side of the east warehouse structure and northern portion of the subject property.

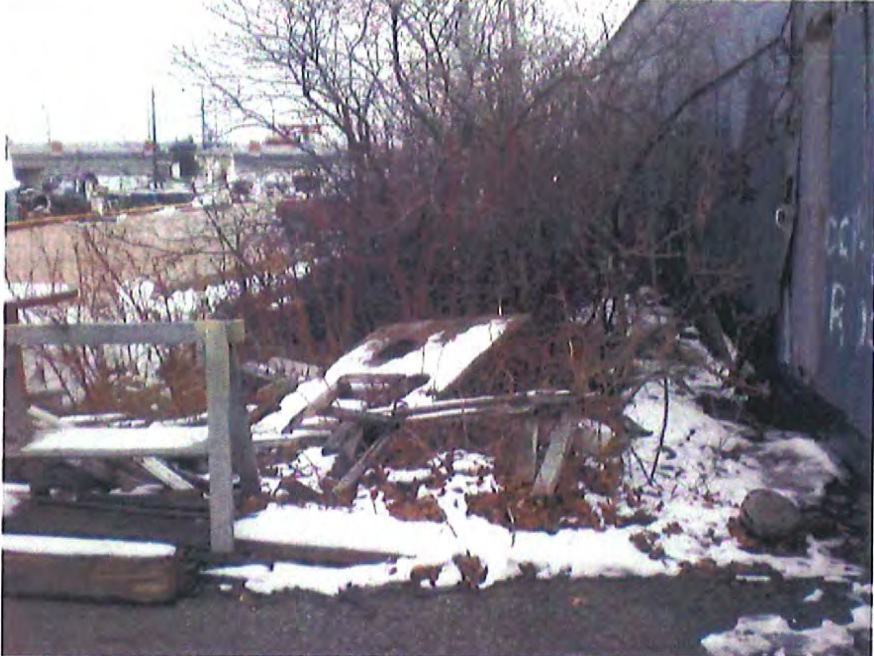
Direction Photo Taken: South			
Description: General debris located along the east side of the east warehouse structure.

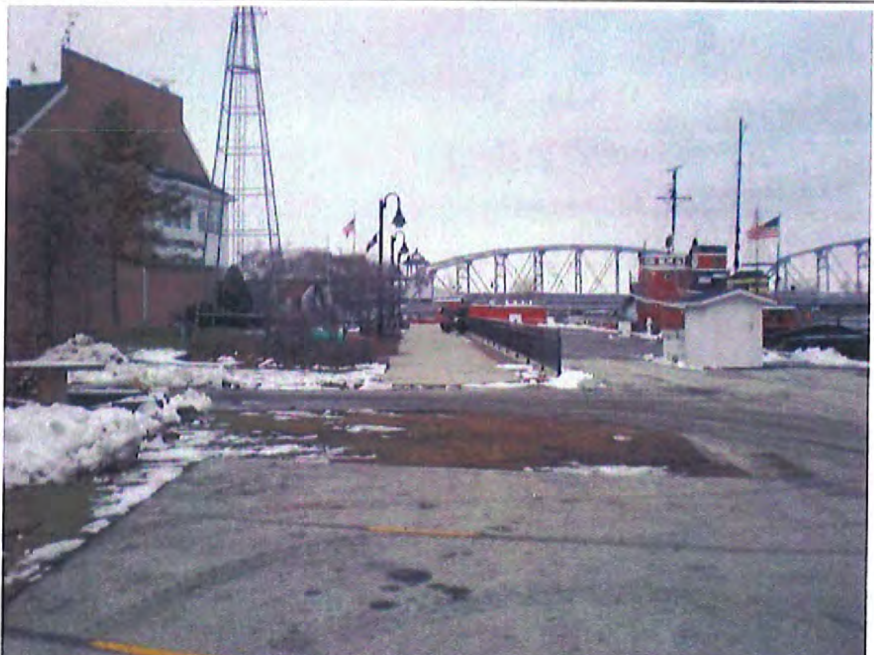
Photo No. 44	Date: 12/14/12

Direction Photo Taken: North		
Description: Looking at the east side of the subject property.

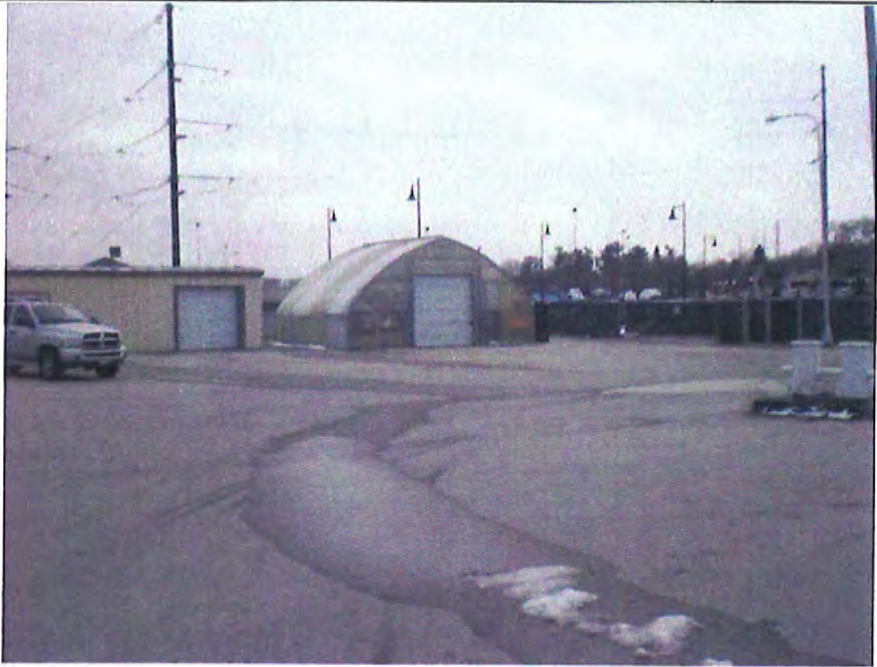
Direction Photo Taken: Southwest			
Description: Storage structure and green house structure occupied by the United States Coast Guard.

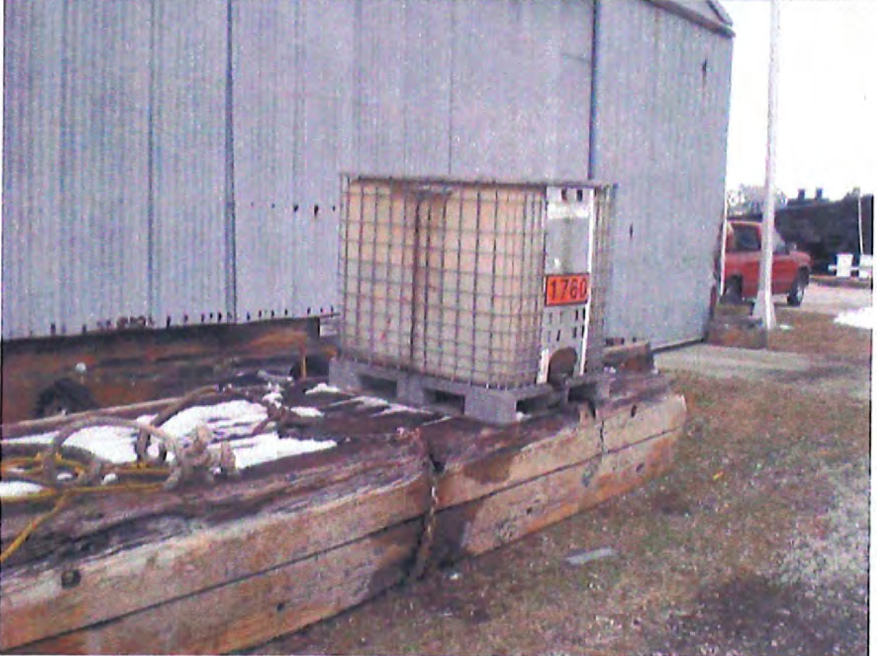
Photo No. 46	Date: 12/14/12

Direction Photo Taken: North			
Description: Tote containing bulk oil located adjacent to the south side of the east warehouse structure.

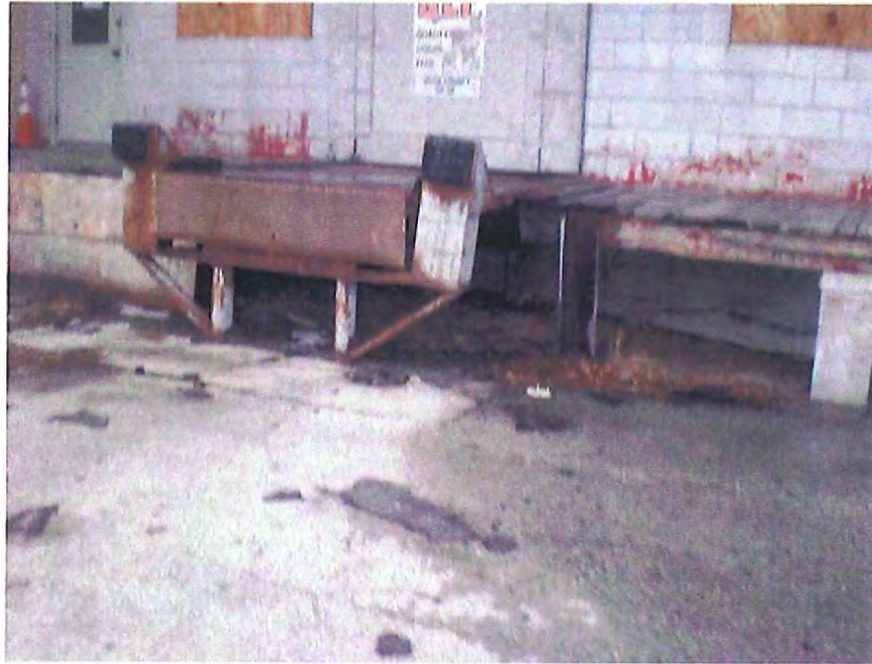
Loading dock adjacent to the south side of the former coop structure.

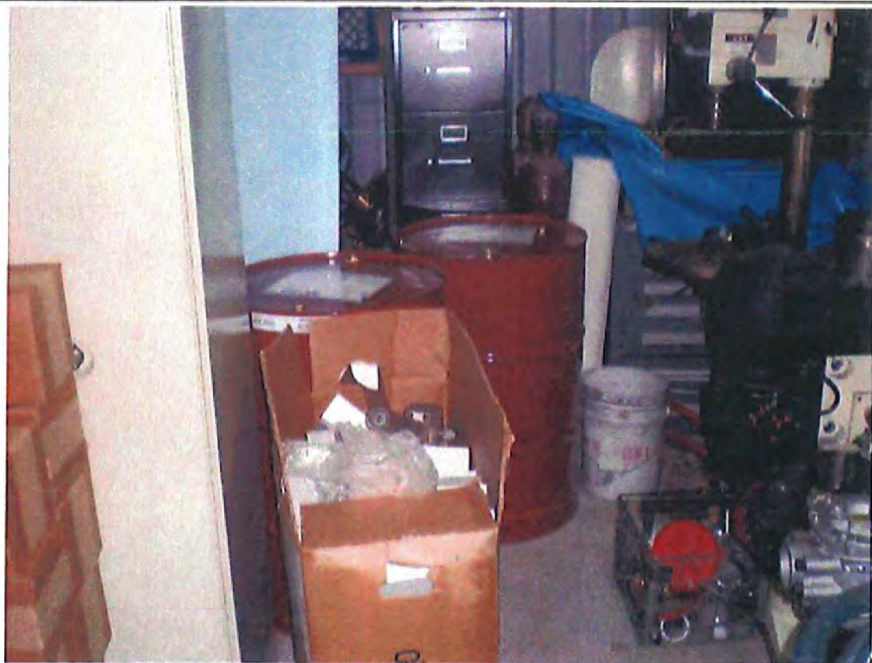
Photo No.
48

Bulk oil containers located within the United States Coast Guard storage structure.

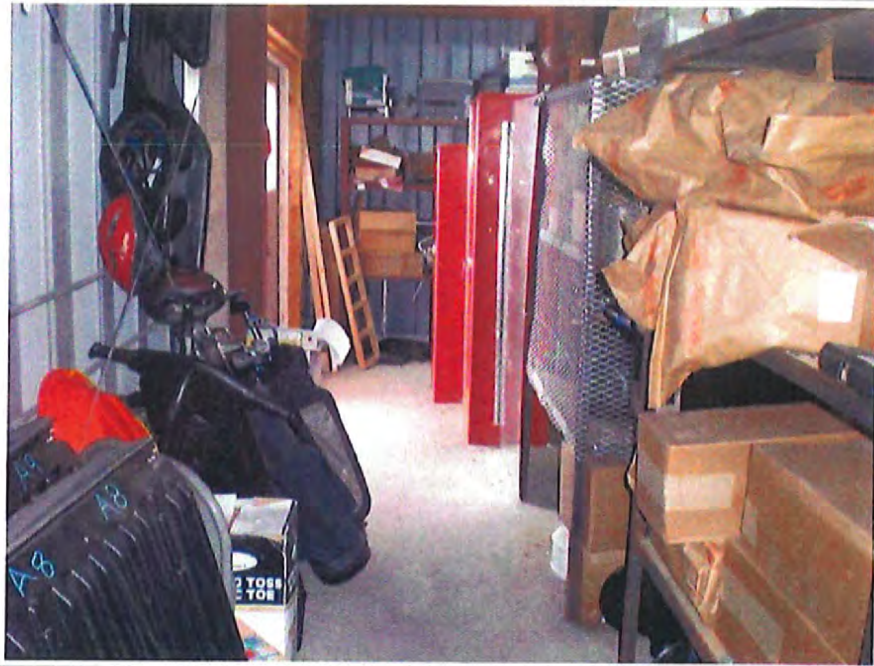
General storage located within the United States Coast Guard storage structure.

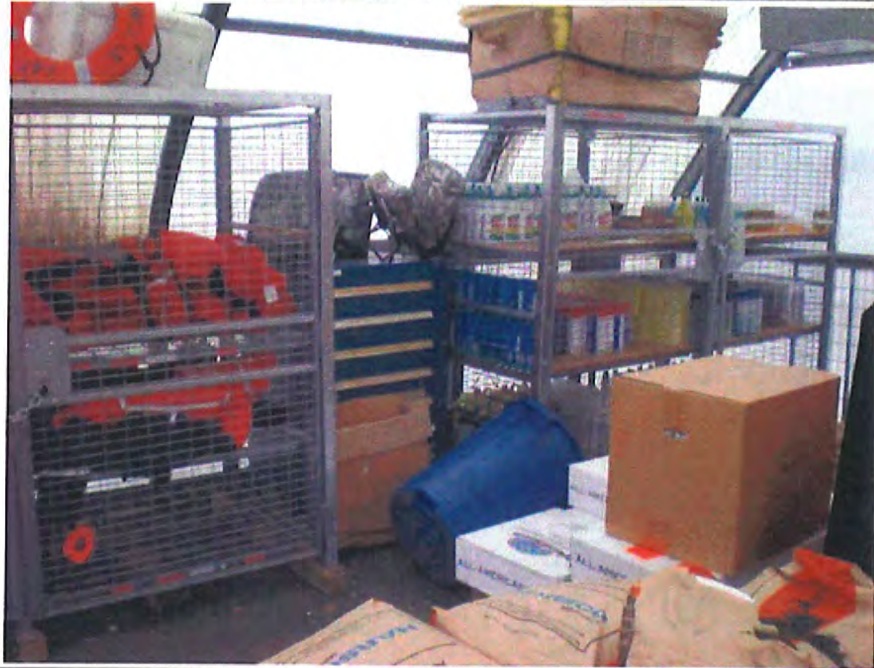
General storage located within the United States Coast Guard greenhouse structure.

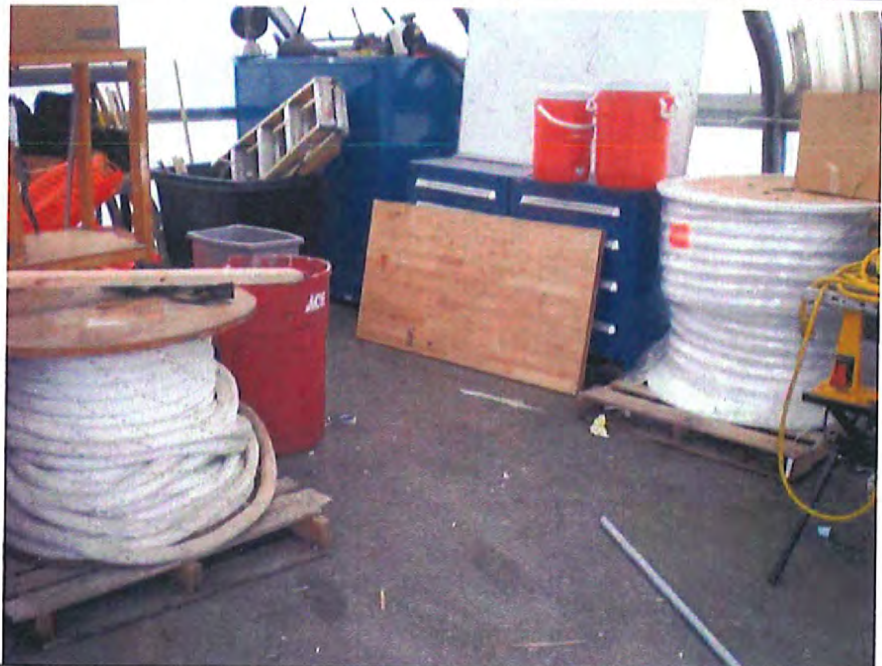
Photo No.
52

General storage located within the United States Coast Guard greenhouse structure.

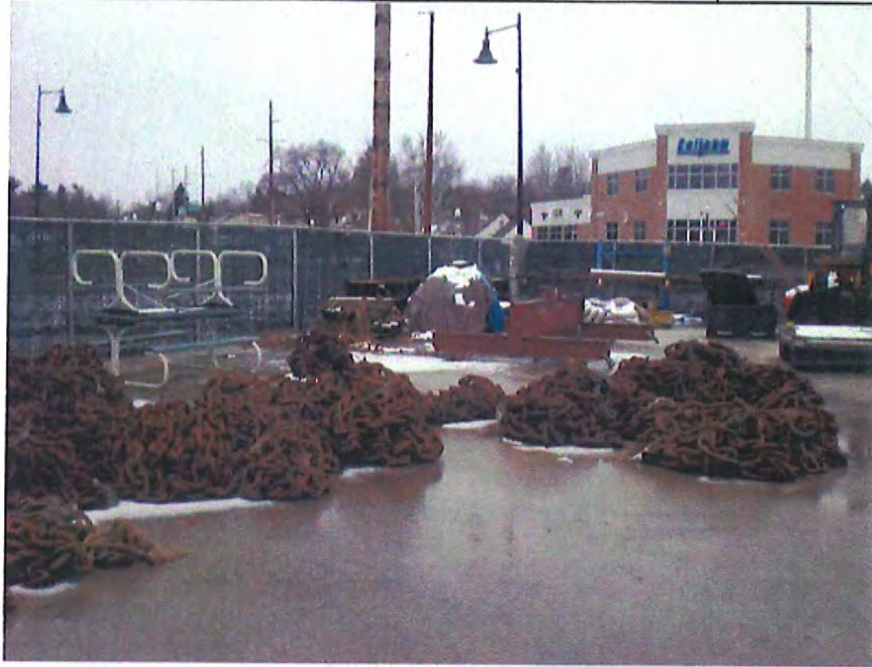
United States Coast Guard exterior fenced storage area.

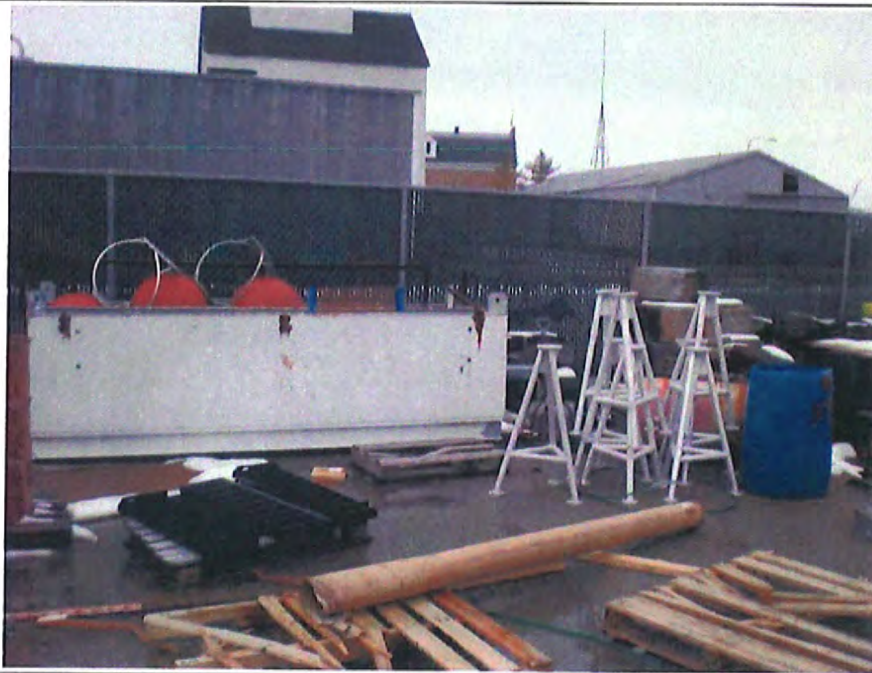
Photo No.
54

United States Coast Guard exterior fenced storage area.

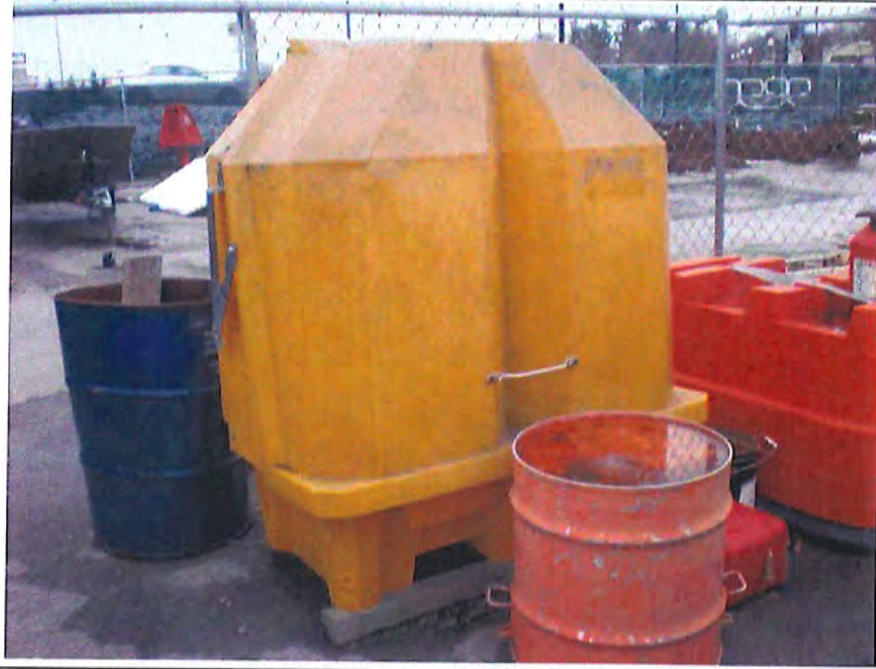
Secondary containment cabinet located within the fenced storage area.
